# Comprehensive Repair Guide for Facade Restoration Professionals

EIFS

STUCCO

CONCRETE/MASONRY

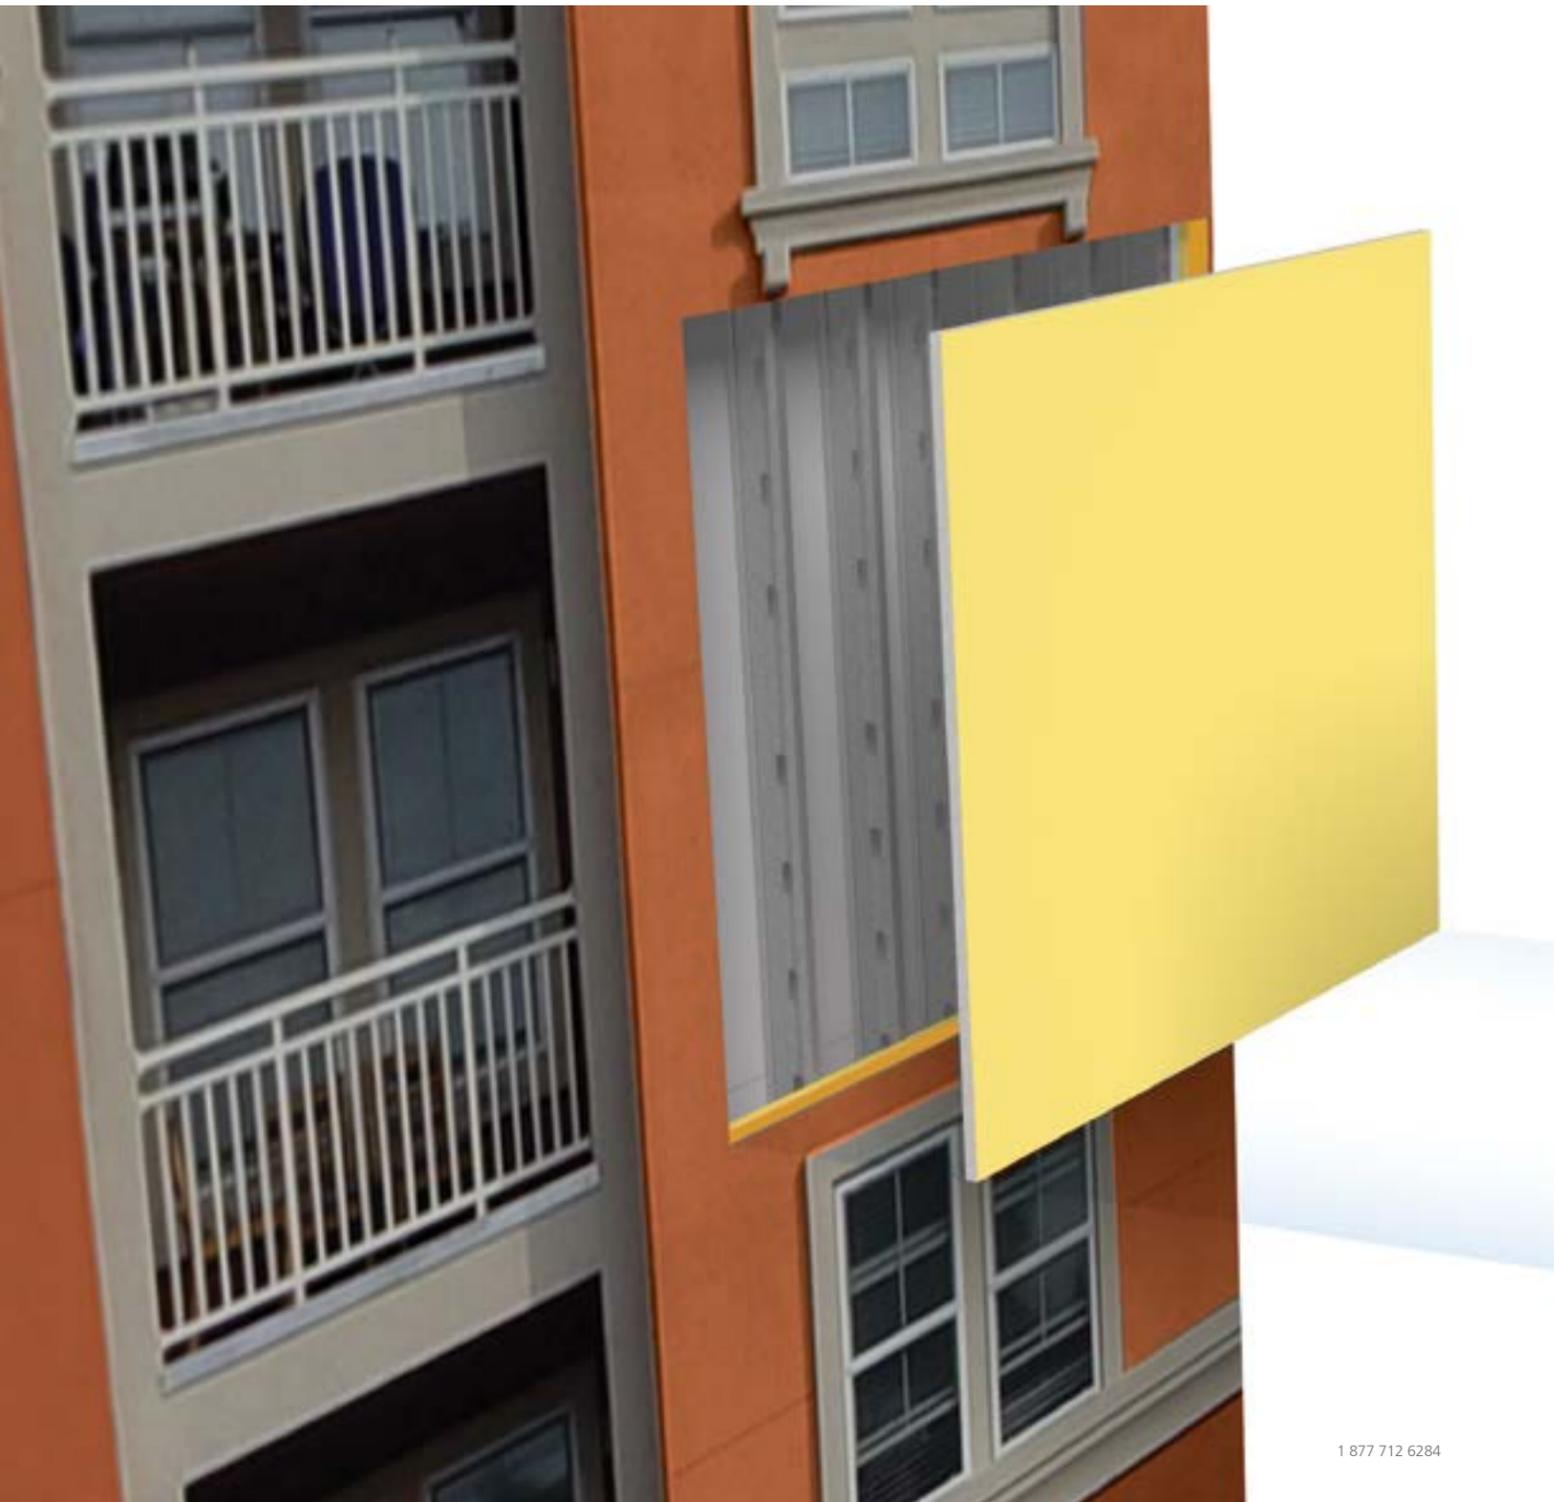
# The Perfect Wall

THE FIVE PLANES OF CONTROL FOR THE IDEAL BUILDING ENVELOPE

The ideal building envelope has five planes of control that must be properly connected and integrated with other building elements. All restoration should be undertaken with an understanding of how each of these layers may be affected.

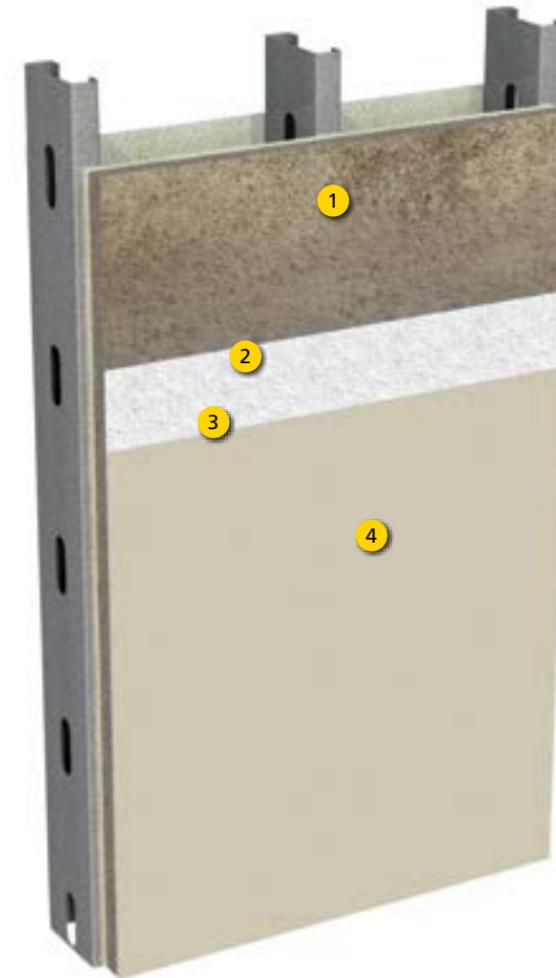
# Clean and Recoat

**1 Clean the surface.** If pressure washing, follow necessary safety precautions and adjust pressure to avoid damage to the substrate. For mold, algae, and mildew removal, treat surfaces with a commercial mildew removal and/or wash product, carefully following manufacturer's application and safety directions. Rinse thoroughly with clean water and allow a minimum of 24 hours to dry thoroughly before application of coating.

**2 Apply StoPrime® Conditioner** evenly with brush, roller or spray equipment to properly prepared substrates if applicable.

**4 Apply tinted Sto iQ Technology™ coating** with specified Sto materials.

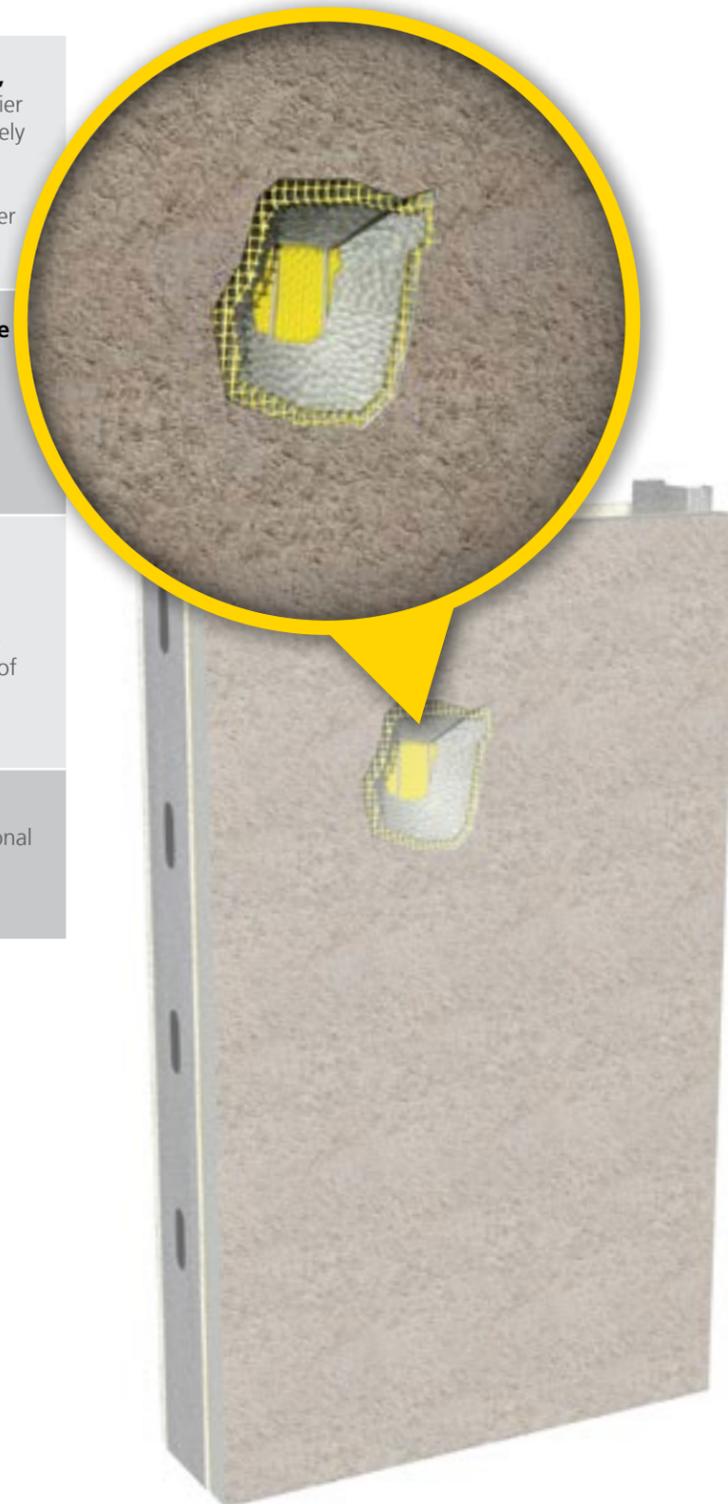
IMPACT DAMAGE

**When EIFS with standard mesh is punctured or cracked, the system is vulnerable to water intrusion.** If it is a barrier EIFS system, water penetration is challenged to drain effectively and may damage the substrate. The risk of water damage is reduced if the EIFS is a drained system in which the water-resistant barrier provides additional protection. However, either system should be repaired as soon as possible.

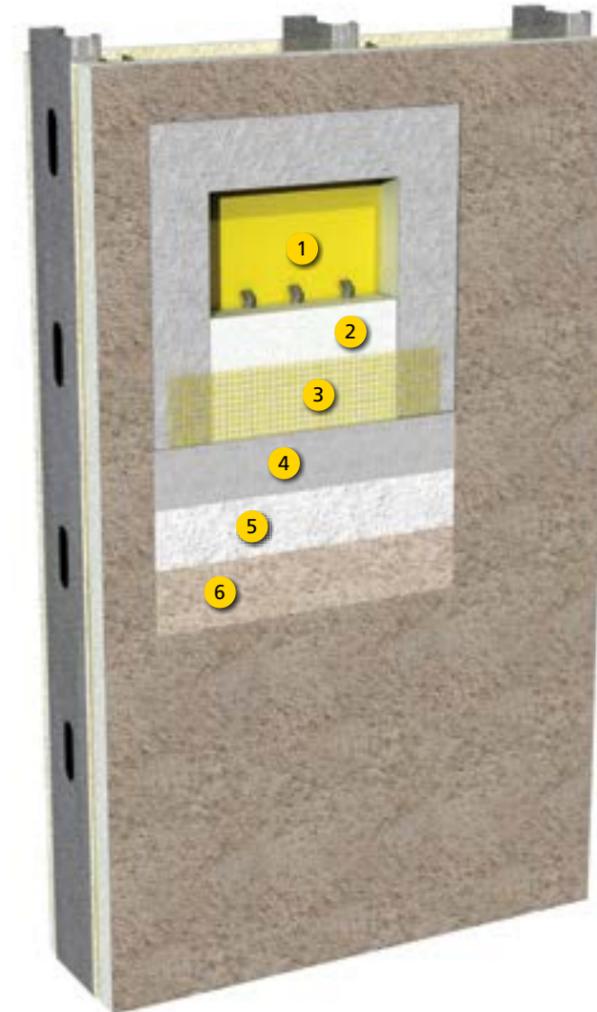
LV2 reStore — DAMAGE REPAIR AND APPEARANCE RESTORATION

- 1 **Cut out** the damaged portion of the EIFS.
- 2 **Repair** the EIFS as per Sto Detail 74.06.
- 3 **Optional:** For added impact resistance, recoat the wall with Sto basecoat and Sto Armor Mat. Allow to cure.
- 4 **Apply Sto basecoat and mesh** to the prepared surface. Allow to cure.
- 5 **Apply tinted StoPrime® primer** appropriate for the finish selected.
- 6 **Refinish the wall** with the specified Sto finish materials.

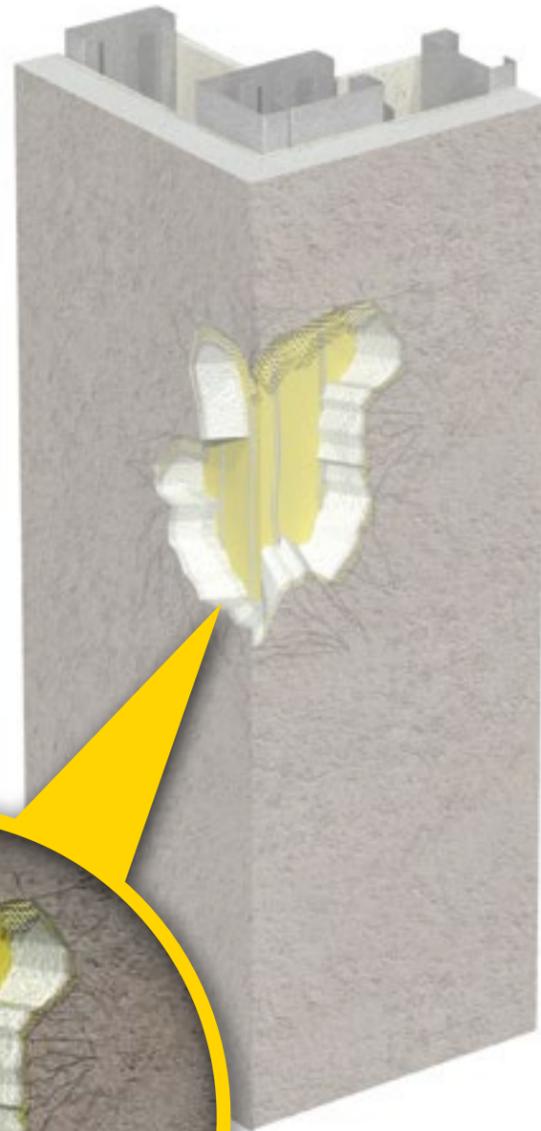
## IMPACT DAMAGE TO CORNERS

**Standard double-wrapped EIFS corners at grade are more vulnerable to damage and water intrusion than walls reinforced with high impact mesh.** If it is a barrier EIFS system, water penetration is challenged to drain effectively and may damage the substrate. The risk of water damage is reduced if the EIFS is a drained system. However, with either system the corner should be repaired as soon as possible.

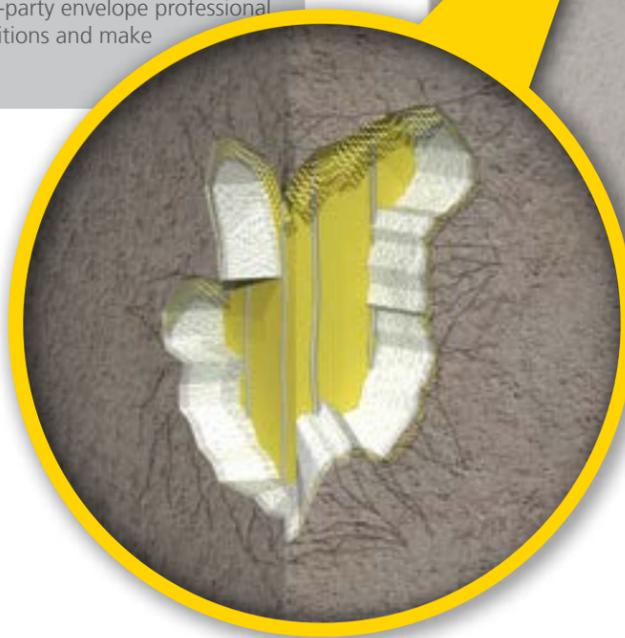
# Damage to EIFS Corners

## LV2 reStore — REPAIR AND RESTORATION OF CORNER

- 1 **Cut out** the damaged EIFS corner back to the substrate.
- 2 **Repair** the EIFS as per Sto Detail 74.08.
- 3 **Optional:** For added impact resistance, recoat the wall with Sto basecoat and Sto Armor Mat Mesh. Allow to cure.
- 4 **Apply Sto basecoat and mesh** to the prepared surface. Allow to cure.
- 5 **Apply tinted StoPrime® primer** appropriate for the finish selected.
- 6 **Refinish the wall** with the specified Sto finish materials.

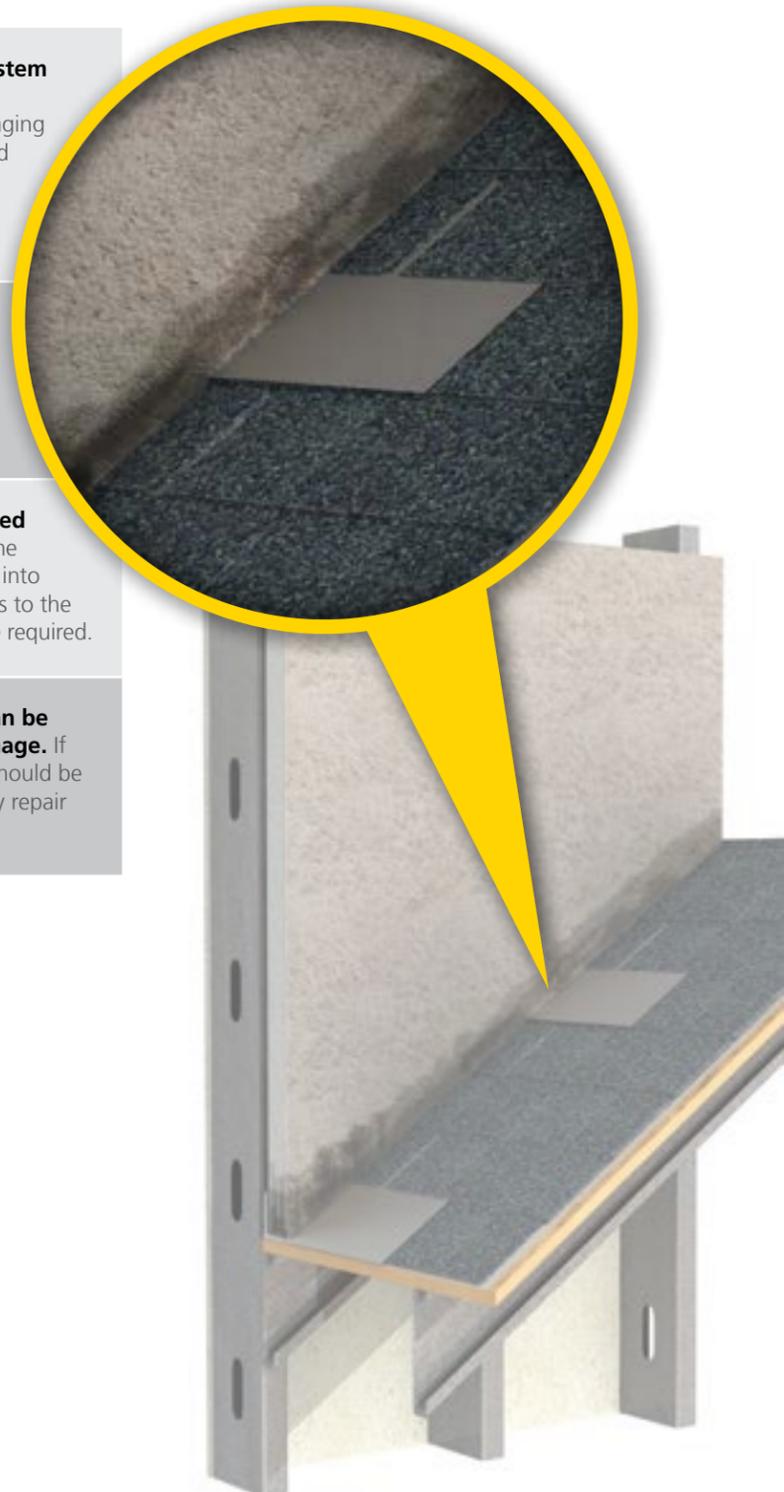
## INADEQUATE SEPARATION BETWEEN ROOFING AND EIFS

**Traditional EIFS detailing recommends that the system terminate 2" (50 mm) above finished roofing.** This clearance allows re-roofing to take place without damaging the EIFS. In addition, the clearance allows for leaves and other natural debris to be cleared by wind or regular maintenance, preventing moisture retention in the debris from staining and deteriorating the finish.

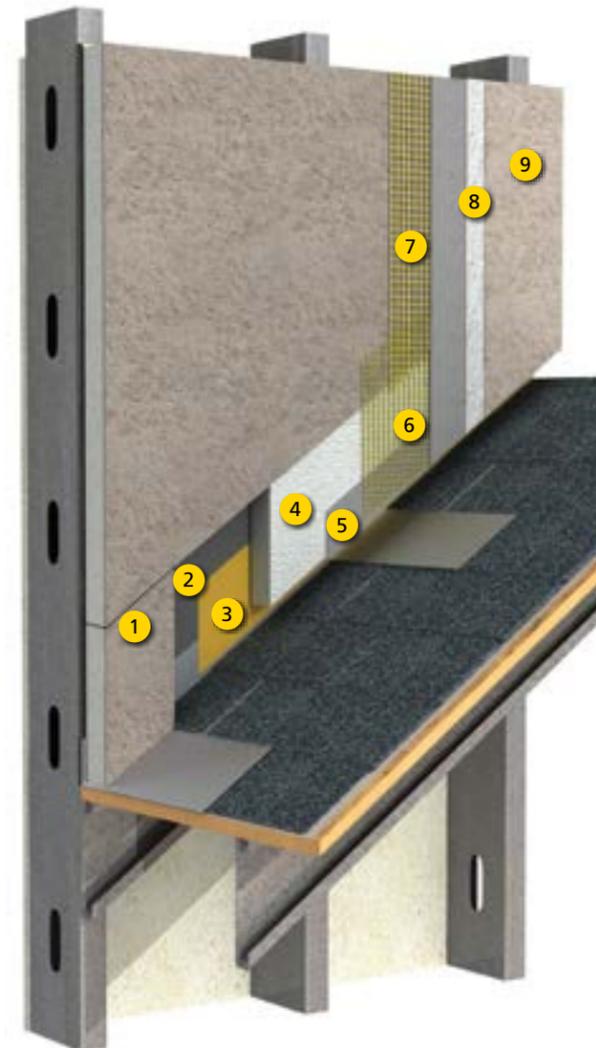
## LV2 reStore — RESTORE SEPARATION AND REPAIR EIFS

- 1 **Cut the EIFS back to the water-resistive barrier**, and to a height of 8" to 12" (200 to 300 mm) above the finished roof.
- 2 **Remove old adhesive** from the substrate.

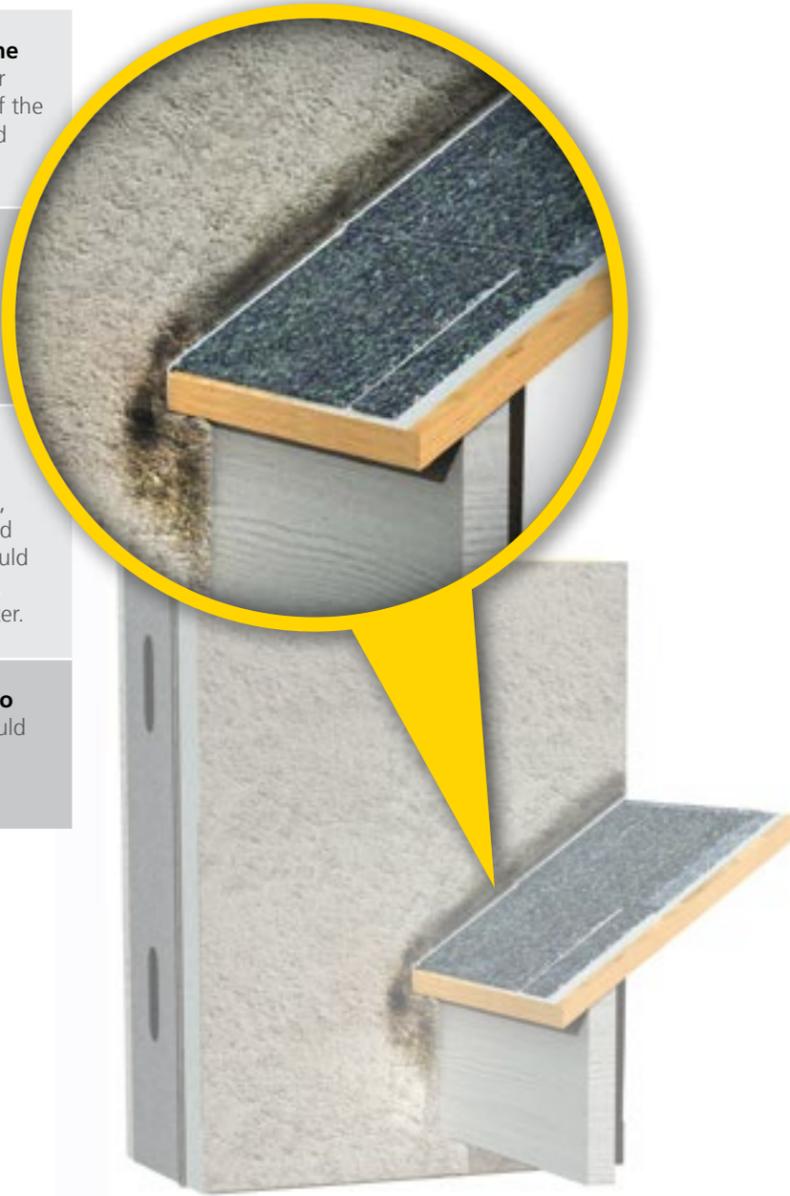
MISSING OR INCORRECTLY INSTALLED DIVERTER FLASHING

**A diverter or 'kick-out' flashing is the termination of the roof step flashings.** If the diverter is missing, inadequate or installed incorrectly, there is a potential for water to drain off the roof into the cladding assembly below. Often, sealant is used as an inappropriate alternative to a diverter flashing.

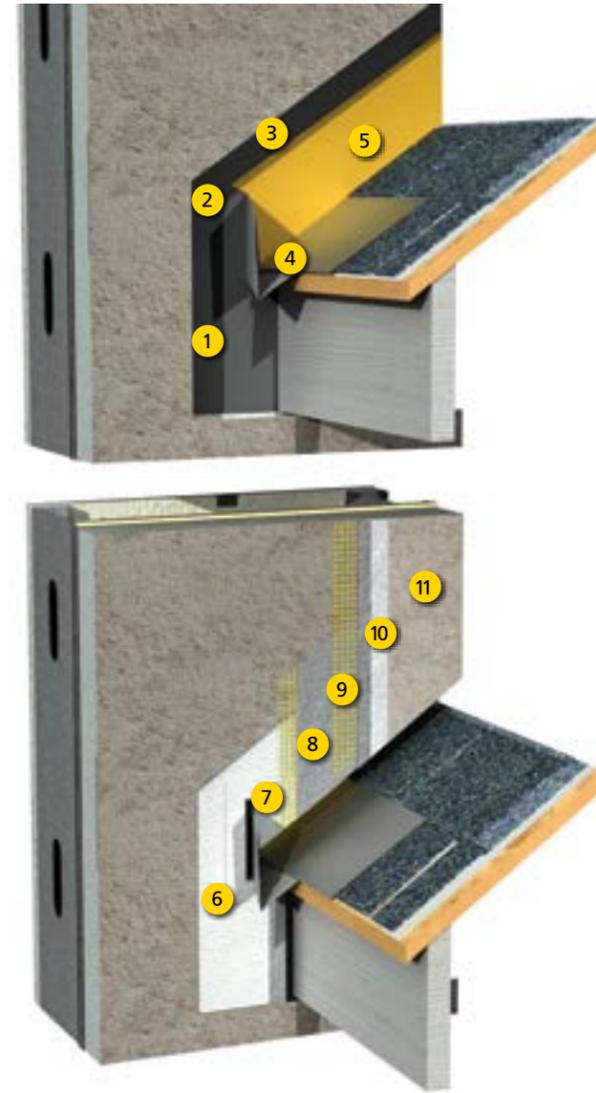
LV2 reStore — DIVERTER INSTALLED AND EIFS REPAIR

- 1 **Remove EIFS** approximately 12" (300 mm) all around the position where the new diverter will be installed.
- 2 **Remove old adhesive** from the substrate.

- 3 **Repair any damage** to the water-resistive barrier.
- 4 **Slide the new diverter flashing** under the step flashing and roof edge flashing.
- 5 **Integrate the waterproof air barrier** with the roof step and diverter flashings by applying Sto RapidGuard® to the substrate and lapping it onto the upturned edge of the flashing.

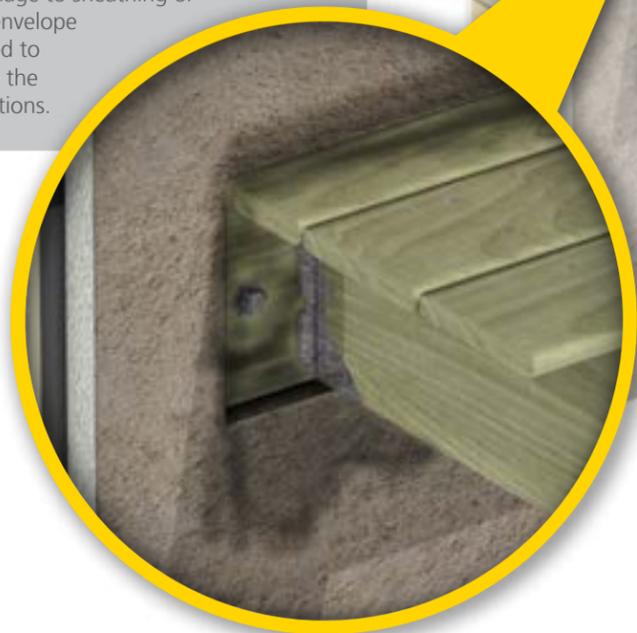
# Deck Connection Flashing Restored

LV2 reStore — FLASHING INSTALLED AND EIFS REPAIR

- 1 **Cut back** the EIFS far enough from the deck to accommodate installation of flashing and repair of the EIFS.
- 2 **Integrate the installation** of flashing with any required deck remediation.
- 3 **Install flashing** to protect the substrate and direct water away from the deck connection.
- 4 **Integrate the flashing** with the StoGuard® air and moisture barrier.
- 5 **Repair** the EIFS terminations as per Sto Detail 72.50.
- 6 **Apply Sto basecoat and mesh** to the prepared surface. Allow to cure.
- 7 **Apply tinted StoPrime® primer** appropriate for the finish selected.
- 8 **Refinish the wall** with the specified Sto materials.

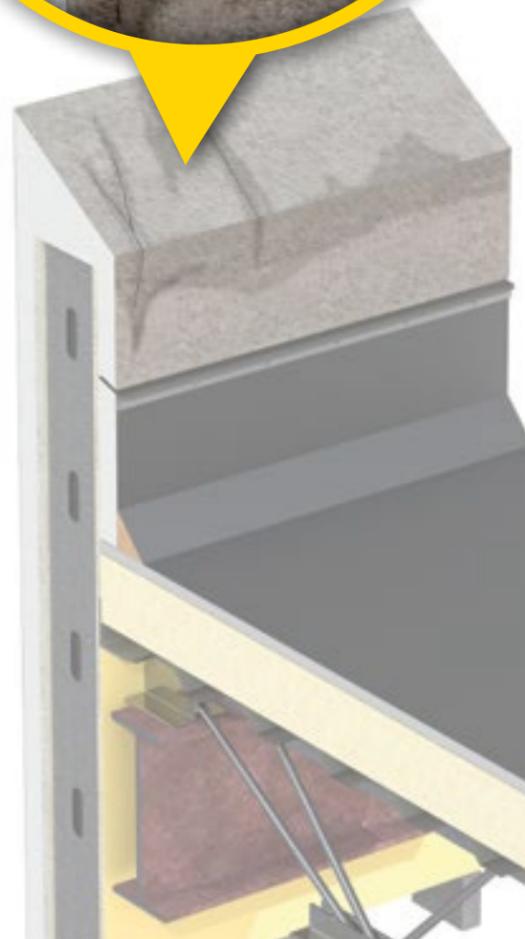
## DAMAGED PARAPET CAP

**EIFS parapet caps were popular design features when EIFS were introduced.** The sharp top edge is subject to physical damage, and the sloped surface endures more weathering than the vertical walls, increasing maintenance requirements. If this is a barrier installation, damage to the EIFS lamina could result in water penetration from the outside and increased air leakage from the interior. All damage to the cap should be repaired as soon as possible.

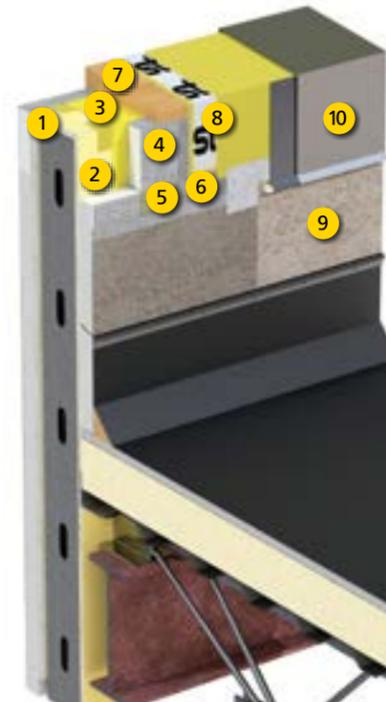
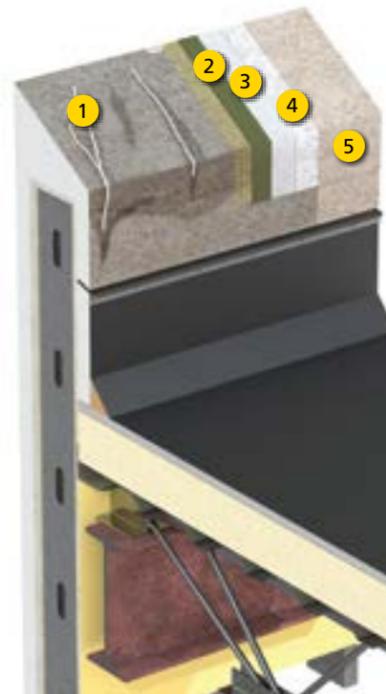
## LV2 reStore — REPLACED OR RESTORED PARAPET CAP

### PARAPET CAP REPLACEMENT

- 1 **Remove the EIFS parapet cap and cladding** to a level 8" to 12" (200 to 300 mm) below the top edges of the substrate.
- 2 **Remove old adhesive** from the substrate.

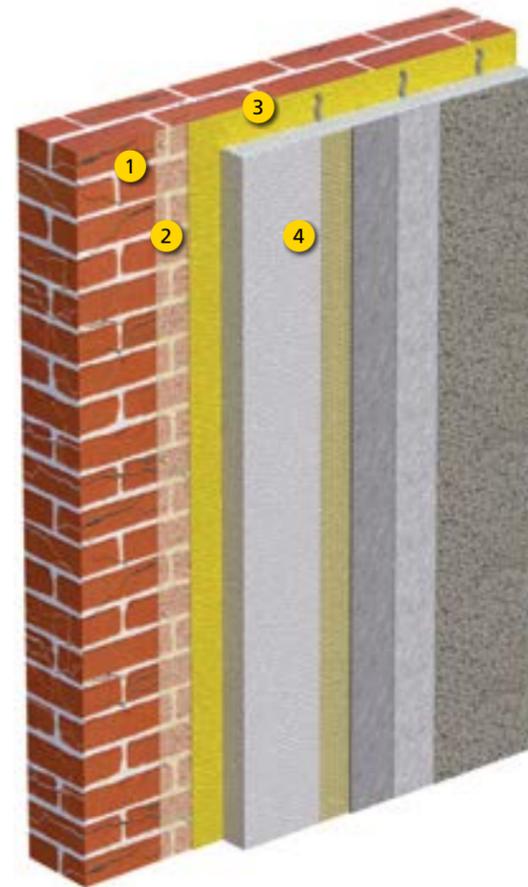
LV3 RESTORE – STOTHERM® CI OVERCLAD USING DISPERSION ADHESIVE

- 1 Clean and prepare surface as needed to ensure a proper bond.
- 2 Apply diluted Sto Dispersion Adhesive in a 15 wet mil coat to substrate with a ½ inch (13 mm) nap roller and let dry.
- 3 Cover the wall with StoGuard® air and moisture barrier.
- 4 Install StoTherm® ci insulated wall cladding, ensuring that all the planes of protection are properly connected.

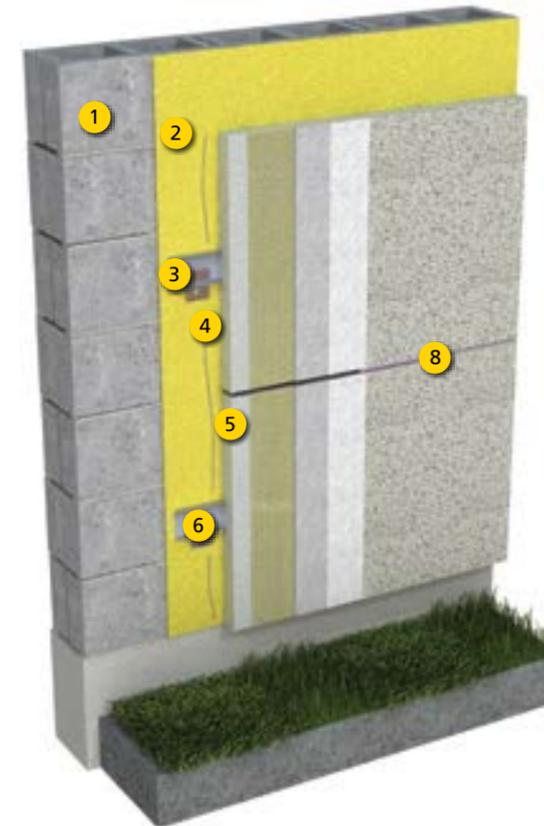
LV3 OR LV4 RESTORE – STOTHERM® CI OVERCLAD OR RECLAD USING PRE-FABRICATED STOLITE PANELS

- 1 **Clean and prepare surface** as needed to ensure a proper bond.
- 2 **Apply StoGuard®** air and moisture barrier.
- 3 **Install clips** that will give the panel the initial support that is needed.
- 4 **Apply approved adhesive** to the back of the panel.
- 5 **Install panel onto clips.** Clips should slide into pre-cut grooves on the C-channel attached to the back of the panel.
- 6 **Fasten StoLite panel to the wall** through C-channel and clip using appropriate fasteners.
- 7 **Allow adhesive to set.**
- 8 **Install backer rod and sealant** per manufacturer's instructions.

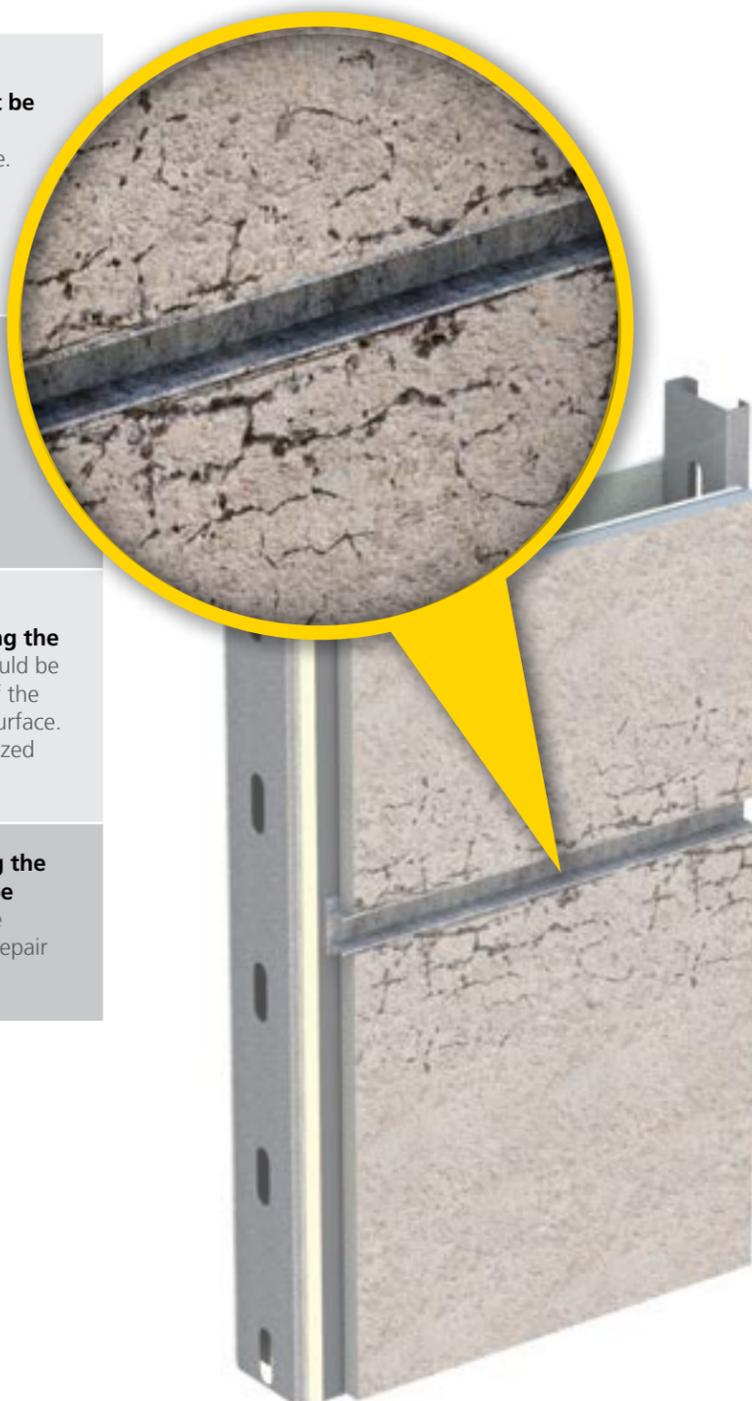
**A foam build-out overclad will avoid removal and replacement of the horizontal reglet while extending the life cycle of the stucco cladding assembly.** Repair should be undertaken in conjunction with the Level 2 restoration of the stucco wall to ensure protection of the water-shedding surface. If both horizontal and vertical one-piece reglets were utilized then a Level 3 overclad is recommended.

# Horizontal Reglets

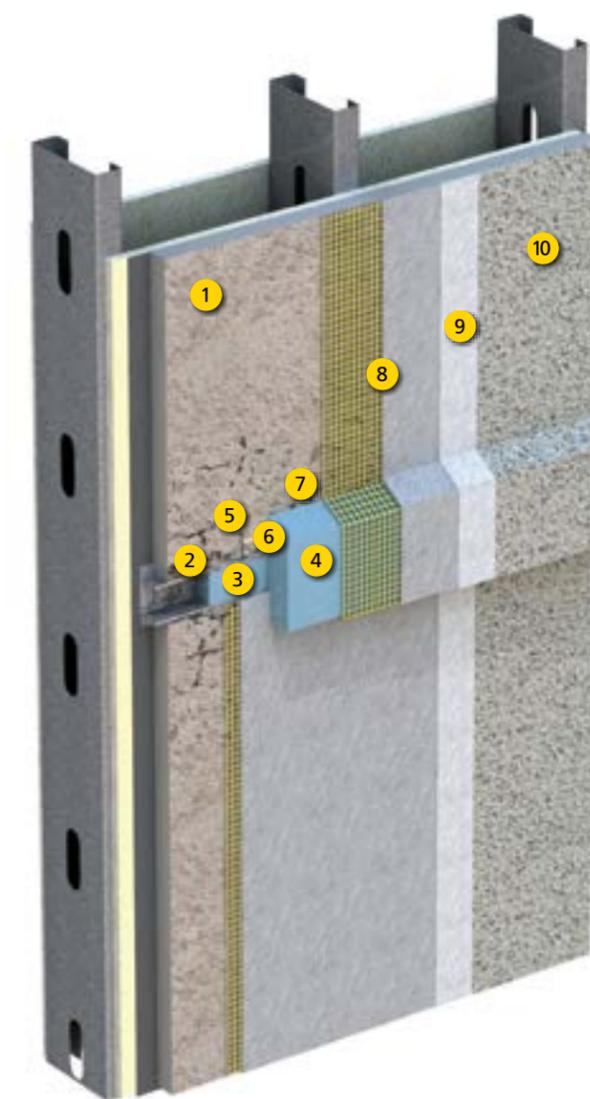
- 1 **Clean entire stucco surface** to remove all contaminants and loose materials.
- 2 **Seal stucco cracks** along the reglet with an acrylic sealant.

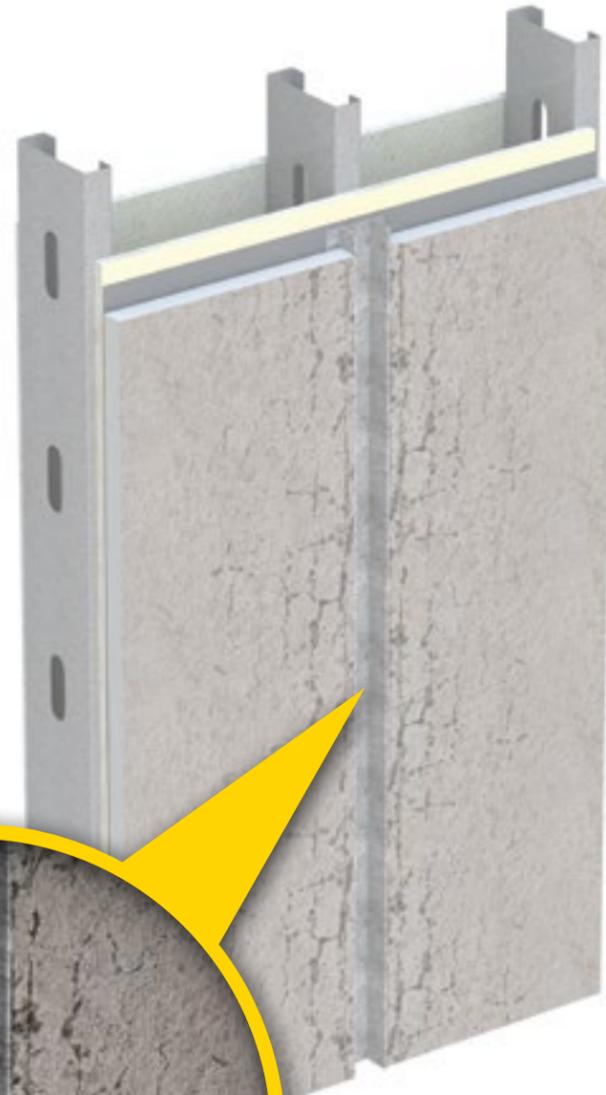
**A foam build-out overclad will avoid removal and replacement of the vertical reglet while extending the life cycle of the stucco cladding assembly.** Repair should be undertaken in conjunction with the Level 2 restoration of the stucco wall to ensure protection of the water-shedding surface. If both horizontal and vertical one-piece reglets were utilized then a Level 3 overclad is recommended.

# Vertical Reglets

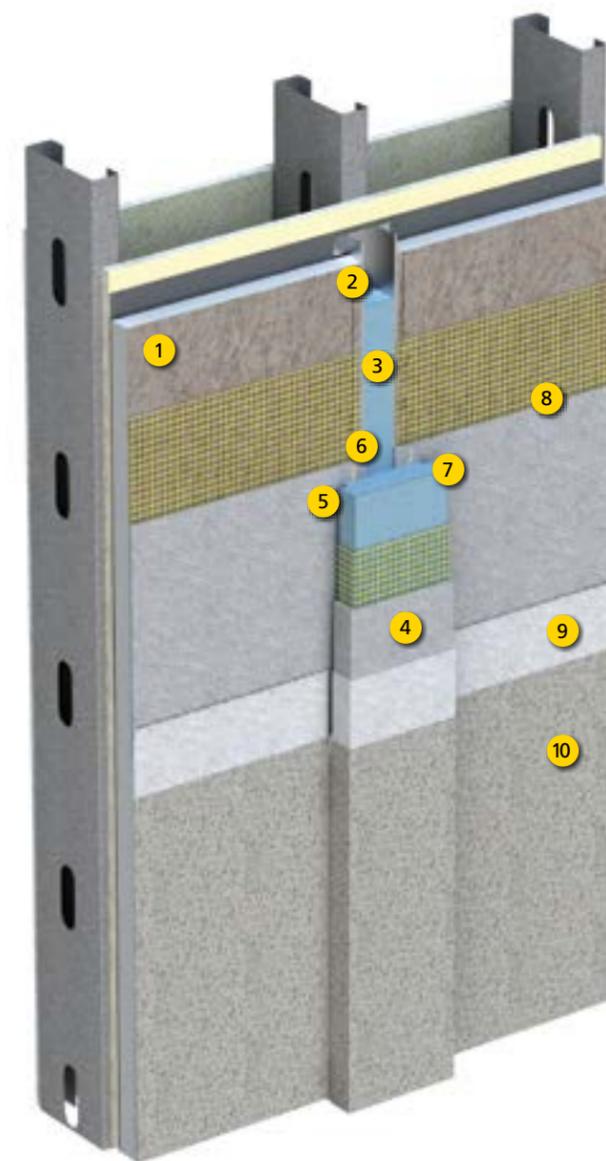
## LV2 reStore — FOAM BUILD-OUT OVERCLAD

- 1 **Clean entire stucco surface** to remove all contaminants and loose materials.
- 2 **Seal stucco cracks** along the reglet with an acrylic sealant.

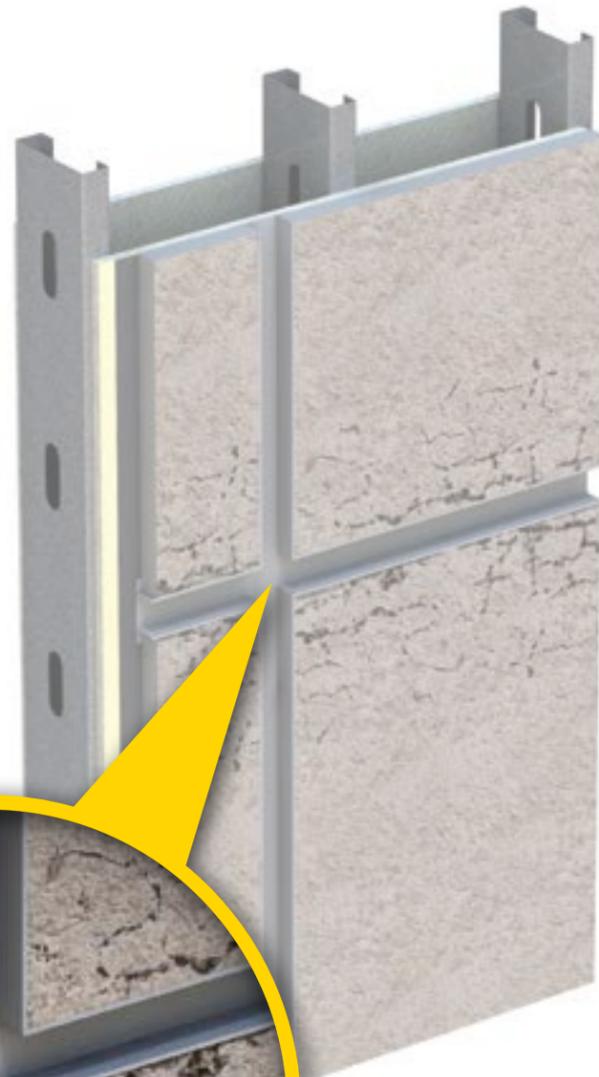
**A StoTherm® ci overclad will avoid removal and replacement of the reglet while extending the life cycle of the cladding assembly.** StoTherm® ci will also enhance the wall's thermal control by reducing thermal bridging and air leakage. The repair must link to the corresponding protection planes of adjacent enclosure assemblies.

# Horizontal and Vertical Reglets

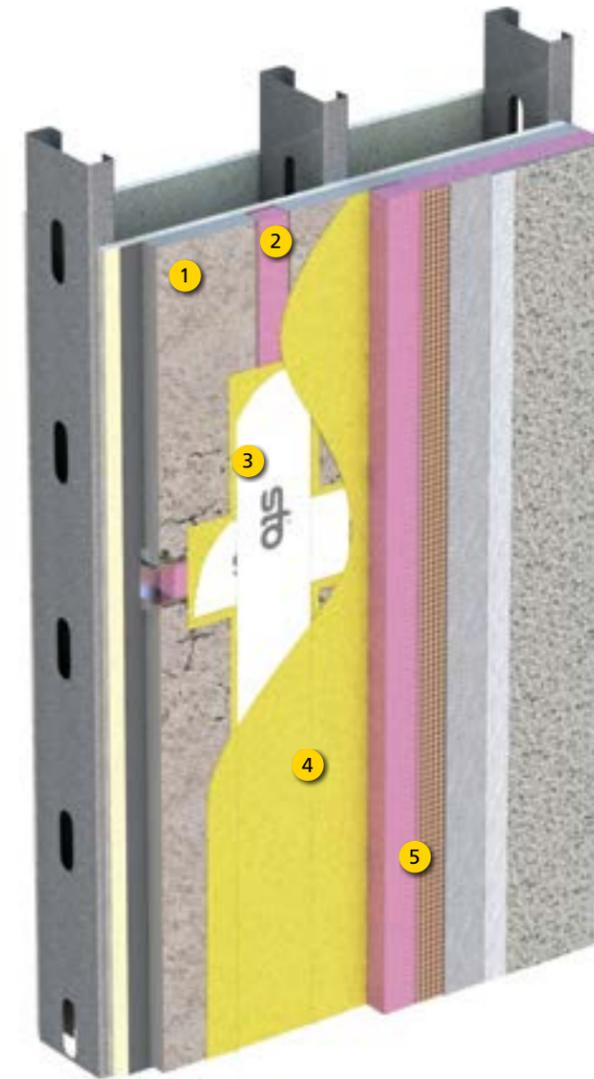
LV3 reStore — STOTHERM CI OVERCLAD

- 1 **Clean entire stucco surface** to remove all contaminants and loose materials.
- 2 **Install a tightly fitting foam insert** into the cavity of the reglet so that it fits flush with the existing surface.
- 3 **Install StoGuard® Transition Membrane** over the reglets as per Sto specifications and details.
- 4 **Apply StoGuard® air and moisture barrier system** over the stucco surface.
- 5 **Install StoTherm ci®** over the wall surface with the specified Sto decorative finish.

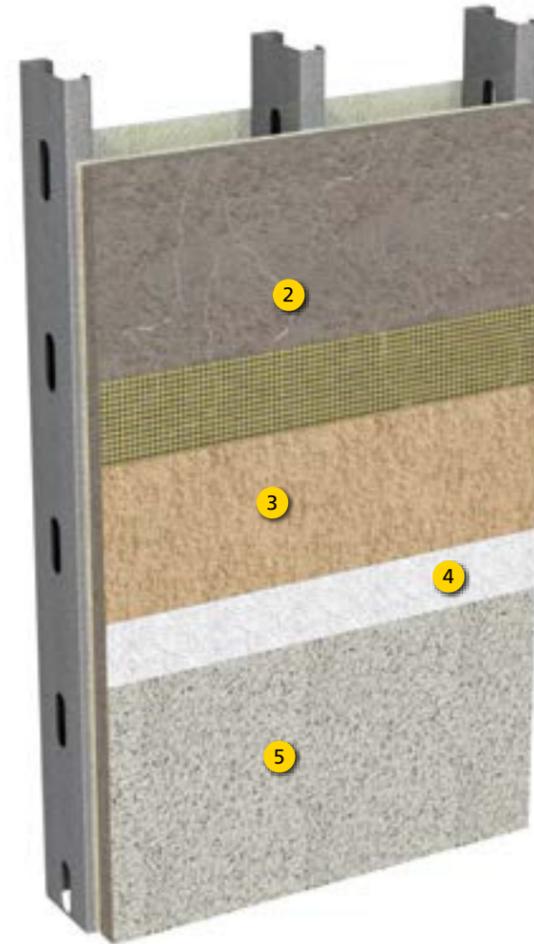
LV2 reStore — MAINTENANCE AND AESTHETIC UPGRADE

- 1 Remove and replace** delaminated stucco as indicated by project engineer after inspection.
- 2 Clean and repair cracks** >1/32 inch to 1/8 inch using Sto Flexible Crack Filler
- 3 Apply Sto RFP and mesh** to the prepared surface and allow to cure.
- 4 Apply tinted StoPrime® primer** appropriate for coating or finish selected.
- 5 Recoat or refinish the wall** with the specified Sto materials.

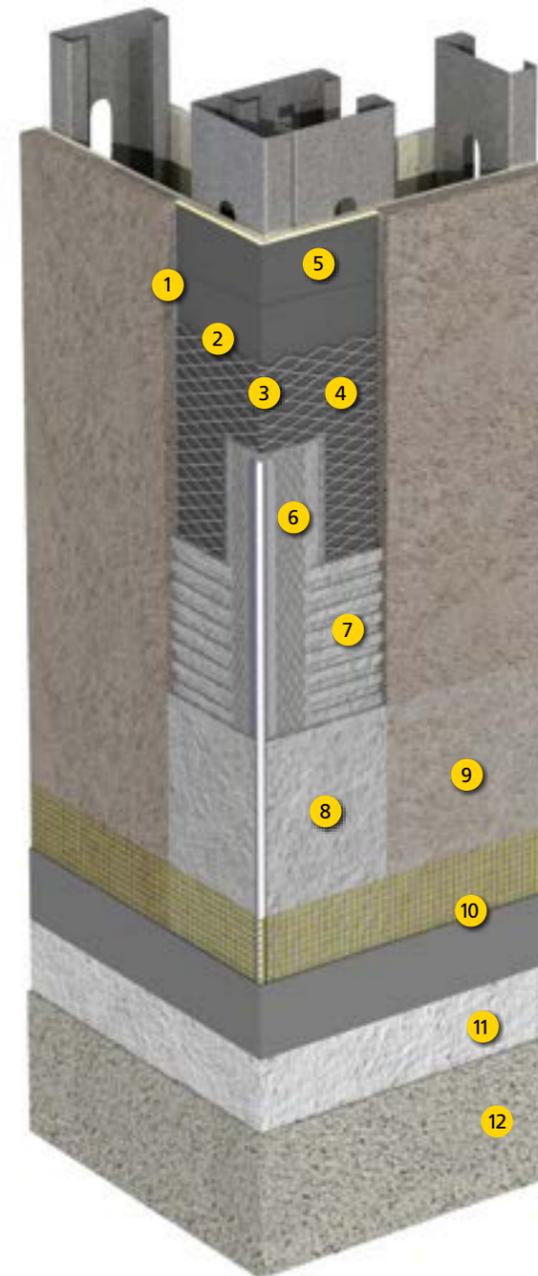
- 1 **Cut the stucco back** to the lath approximately 6" (150 mm) on each side of the corner. Remove the stucco down to the lath.
- 2 **Carefully remove fasteners** or ties supporting the corner bead.

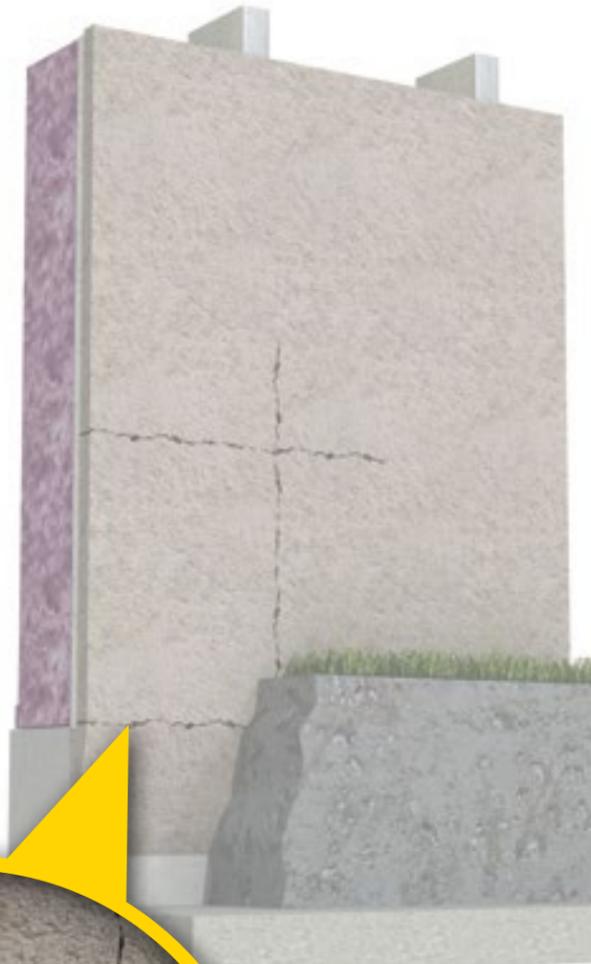
**With landscaping removed, the stucco and sheathing can be cut away from the base of the wall and the stucco termination repositioned.** Repairs will use more damage-resistant materials and incorporate the required flashing. The repair will create a drainage path from behind the stucco and increase protection against water penetration.

# Stucco on Frame Wall at Grade

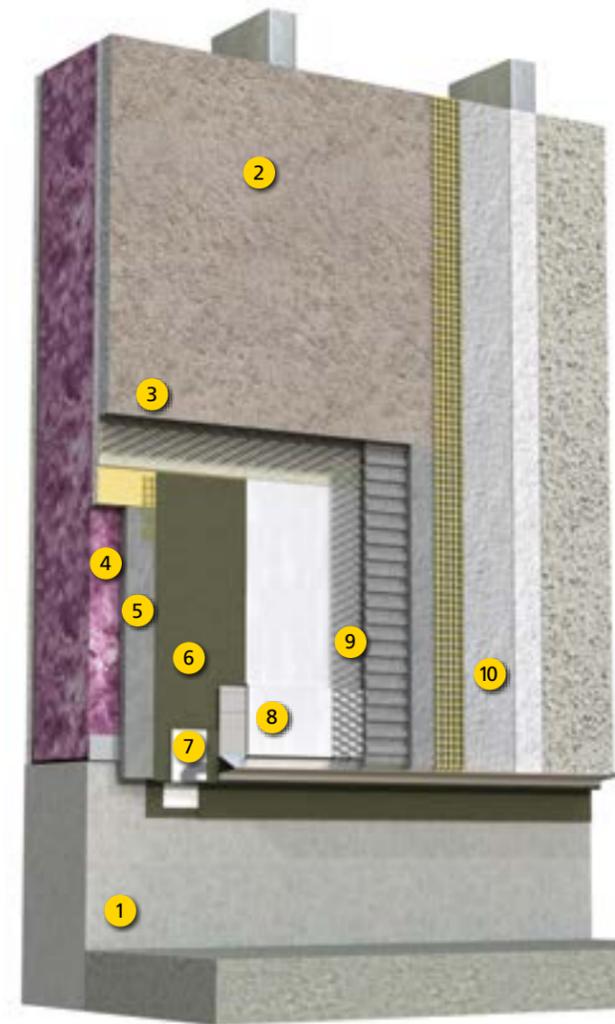
LV2 reStore — STUCCO RESTORED ABOVE GRADE

- 1 **Clear away landscaping and soil** from the stucco and foundation.
- 2 **Remove loose finish and repair cracks** and surface damage as per Sto Repair and Maintenance Guide.

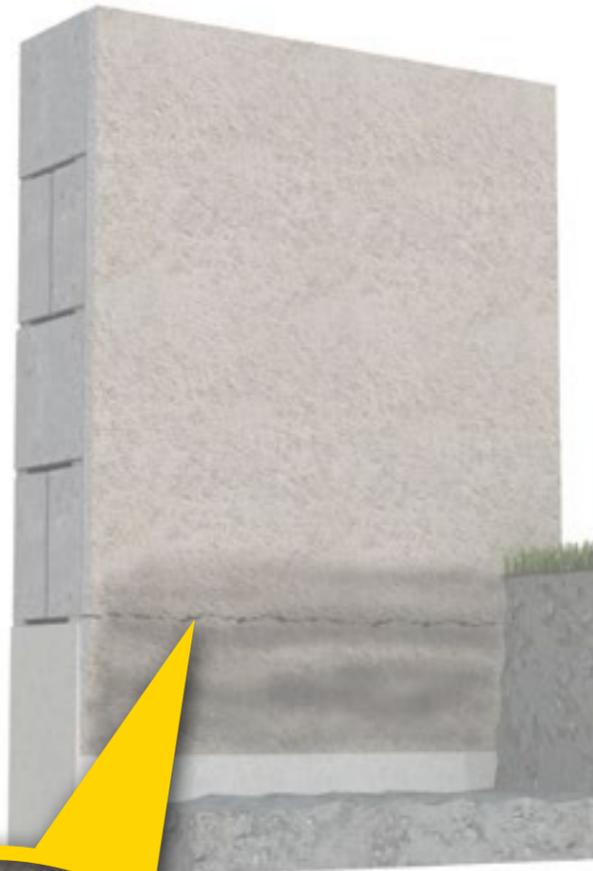
**With landscaping removed and the stucco termination cut away, the repair can be made as an integral part of refinishing the wall or as a stand-alone repair.** The new termination will include waterproofing layers and code-compliant flashing to direct water away from the wall. Keeping water away from the foundation is outside the scope of the repair, but will require regrading the landscape away from the building or adding drains.

# Stucco on CMU Termination at Grade

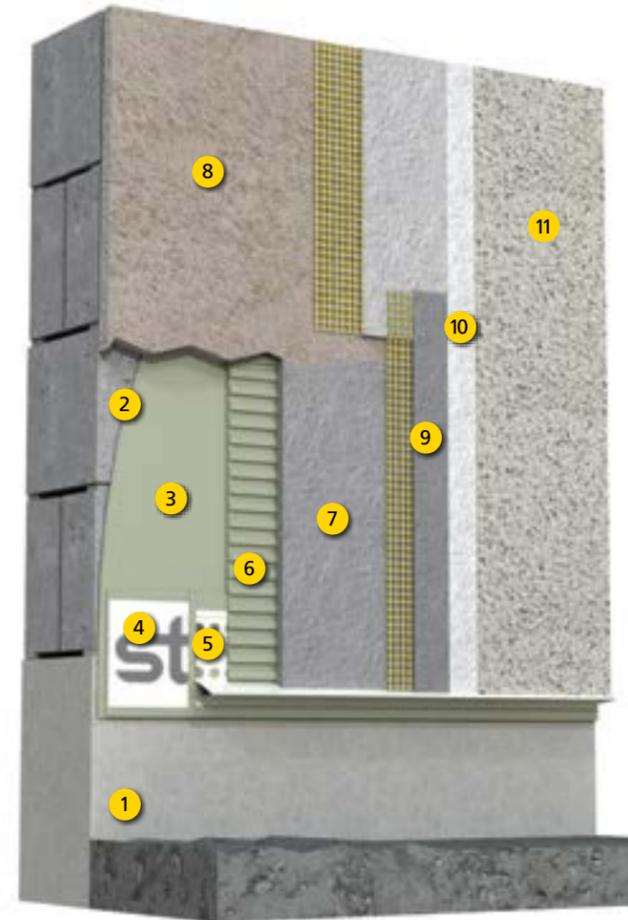
## LV2 reStore — FLASHING INSTALLATION AND IMPROVED WATER RESISTANCE

- 1 **Clear landscaping and soil** a minimum of 8" (200 mm) below the top of the foundation.
- 2 **Remove the stucco from the base of the wall** to a height of approximately 16" (400 mm) above the foundation. Remove all loose material and dust from the surface of the CMU and concrete foundation.

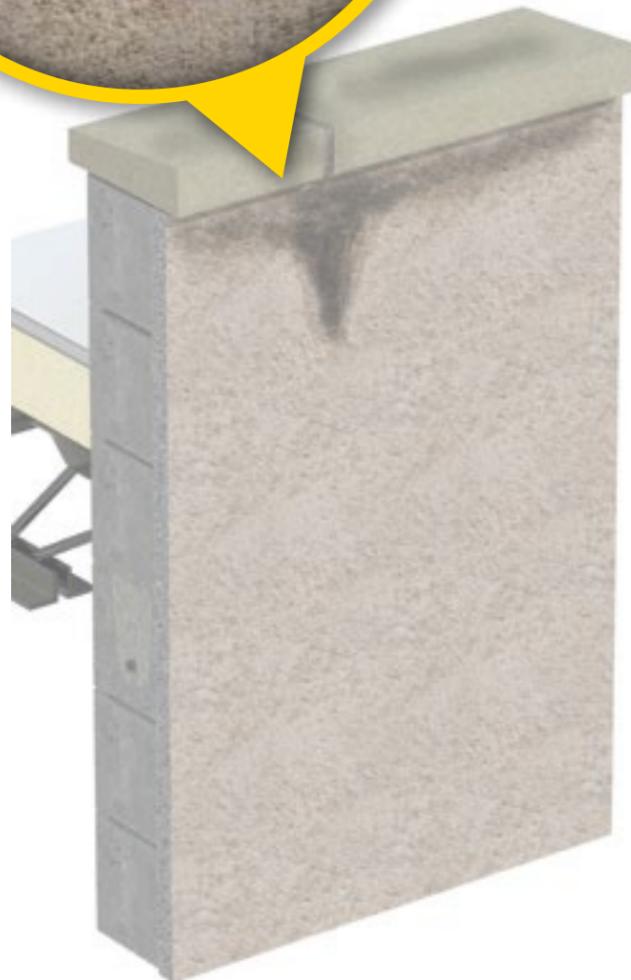
The slope of the cap can be modified so water drains towards the roof. Waterproof coatings, integrated with the new wall finish, will further improve the parapet's water resistance. Where specified, the inner face of the parapet wall may be refinished, integrating the waterproofing with roof membranes and flashings.

# Concrete Parapet Cap
