# Comprehensive Repair Guide for Facade Restoration Professionals

EIFS

STUCCO

CONCRETE/MASONRY

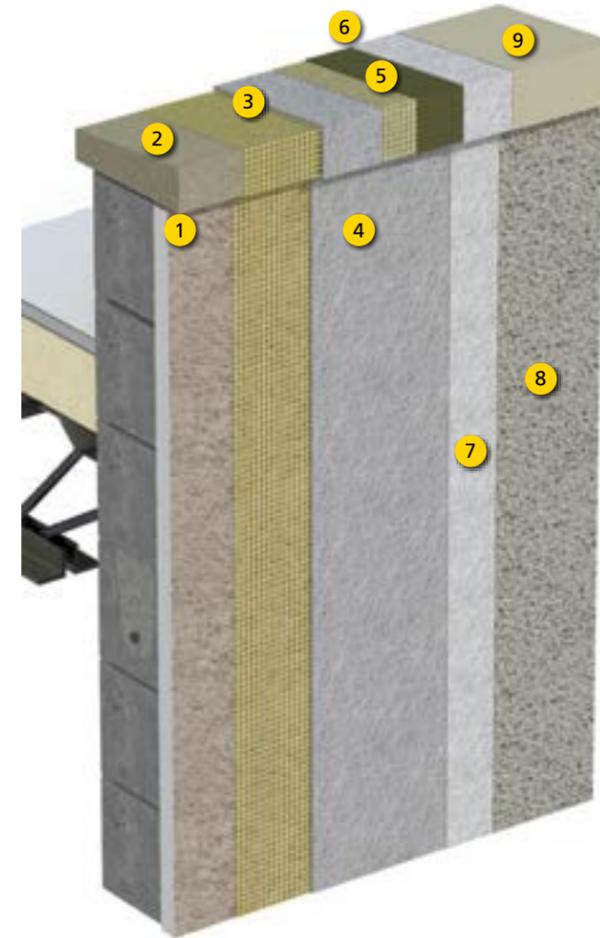
- 1 Remove dirt accumulations on the parapet cap and on the face of the wall.
- 2 Clean and repair the cap mortar joints.
- 3 Using additional applications of Sto basecoat, increase the slope of the parapet cap towards the roof.
- 4 Apply Sto basecoat and mesh to the prepared surface, wrapping over the parapet cap and, ideally, terminating at the roof flashing. Allow to cure.
- 5 Install an application of Sto waterproofing membrane and Sto Mesh over the recoated parapet cap.
- 6 Where specified, continue the Sto waterproofing membrane to the back side of the masonry parapet and integrate with the roof membrane and flashing.
- 7 Apply tinted StoPrime® primer appropriate for the finish selected.
- 8 Refinish the wall with the specified Sto materials.
- 9 Coat the parapet cap with two coats of appropriate StoColor® coating.

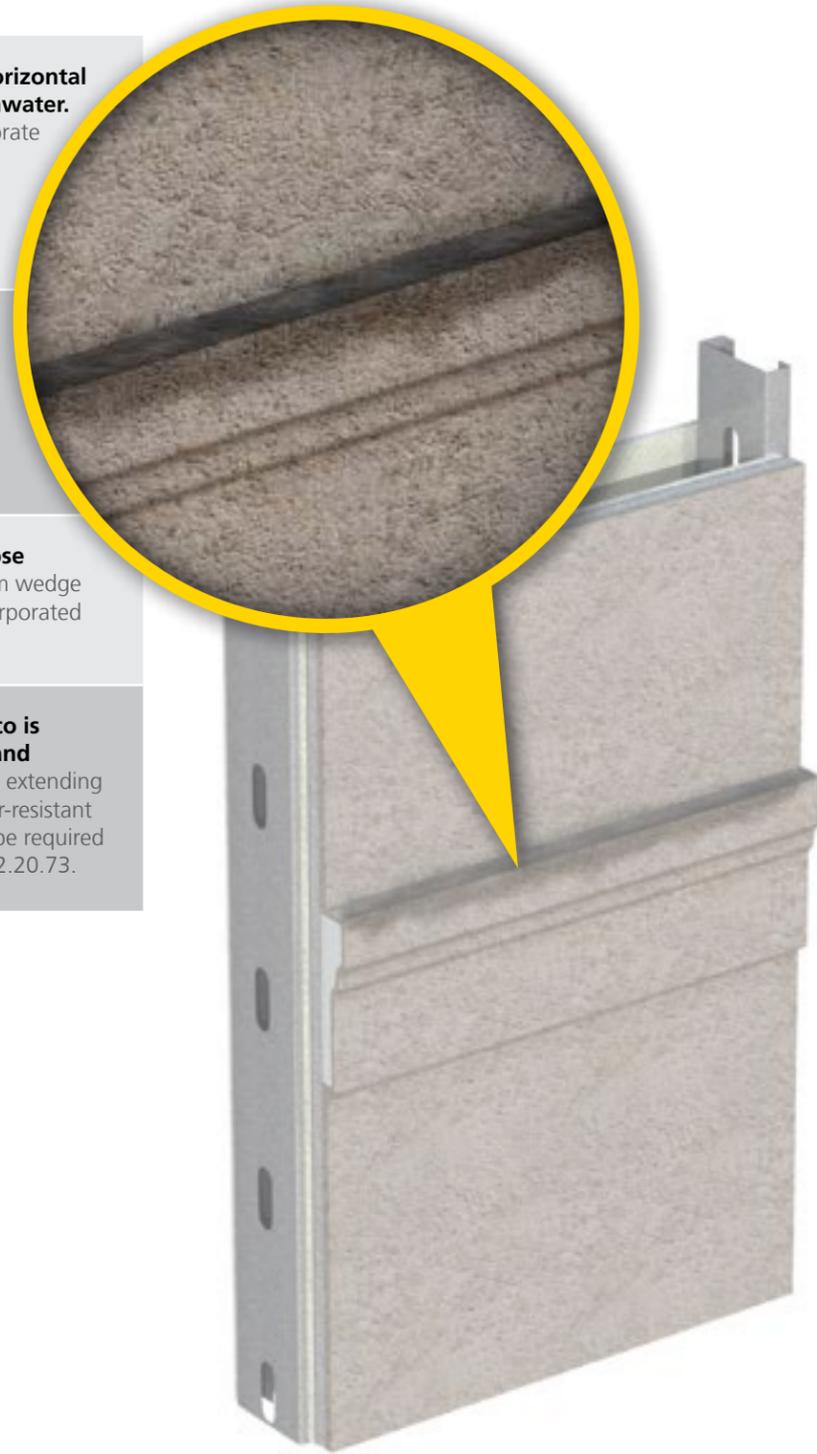
**The profile and wall will be cleaned and any loose finish removed prior to refinishing.** A simple foam wedge will be added to the top edge of the profile and incorporated into the new finish.

# Feature Profile

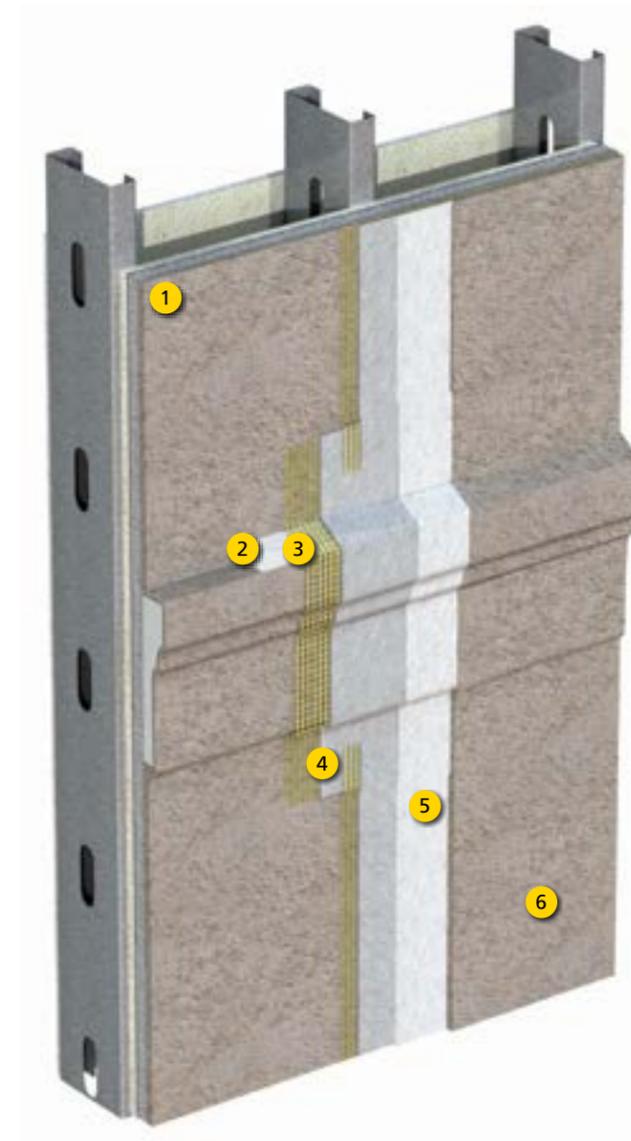
- 1 **Clean the wall**, removing all dirt and loose material.
- 2 **Bond a foam wedge** to the top of the profile with Sto adhesive, increasing the slope to a minimum 1:2 (27°). In climates where snow and ice may accumulate, increase the slope to 1:1 (45°).
- 3 **Allow the adhesive to cure for 24 hours**, then rasp the foam wedge so that it is even with the face of the profile.
- 4 **Apply Sto basecoat and mesh** to the prepared surface and foam profile. Allow to cure.
- 5 **Apply tinted StoPrime® primer** appropriate for the finish selected..
- 6 **Refinish the wall** with the specified Sto materials.

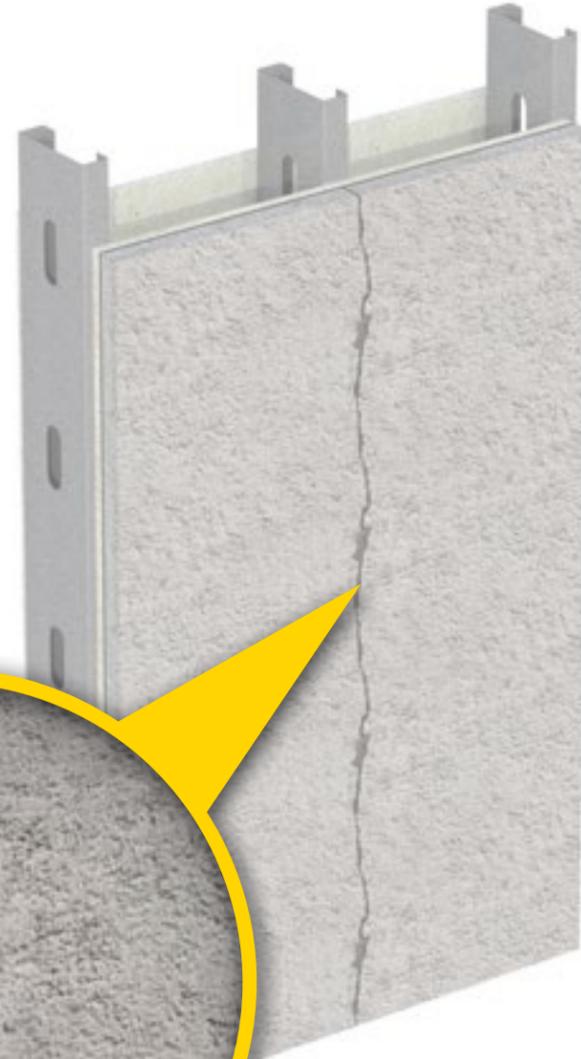
**It is likely that a functional joint will be required.** The joint, which will run the full height or width of the stucco panel, may be installed as a stand-alone repair or as part of a complete facade restoration.

# Crack Through Stucco

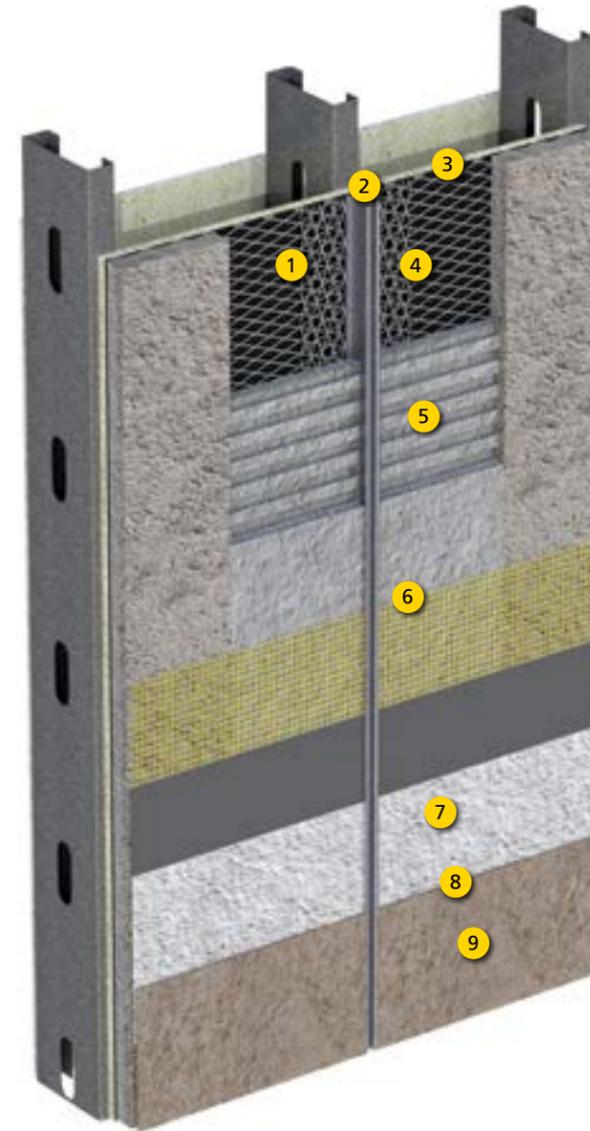
**1** **Between horizontal joints,** remove stucco to a minimum width of 4" (100 mm) on each side of the crack, exposing the lath.

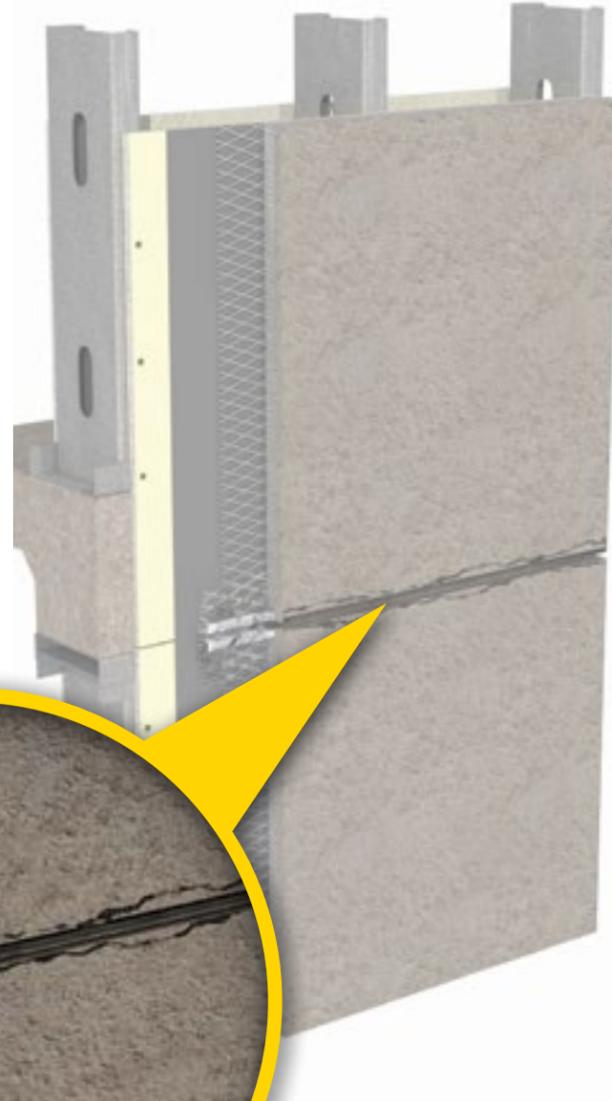
# Floor-Line Joints and Flashing

**An effective functional joint option is back-to-back casing beads with integrated flashing to direct water to the exterior.** The stucco and failed joint must be removed, and the lath cut for insertion of flashing behind the water-resistive barrier. The new joint can then be installed.

**If water has intruded behind the cladding, further evaluation is necessary to ensure that the lath and water-resistive barrier are not damaged.** If there is any evidence of water penetration behind the water-resistive barrier, a third-party envelope professional should be retained to evaluate conditions and make the necessary repair recommendations.

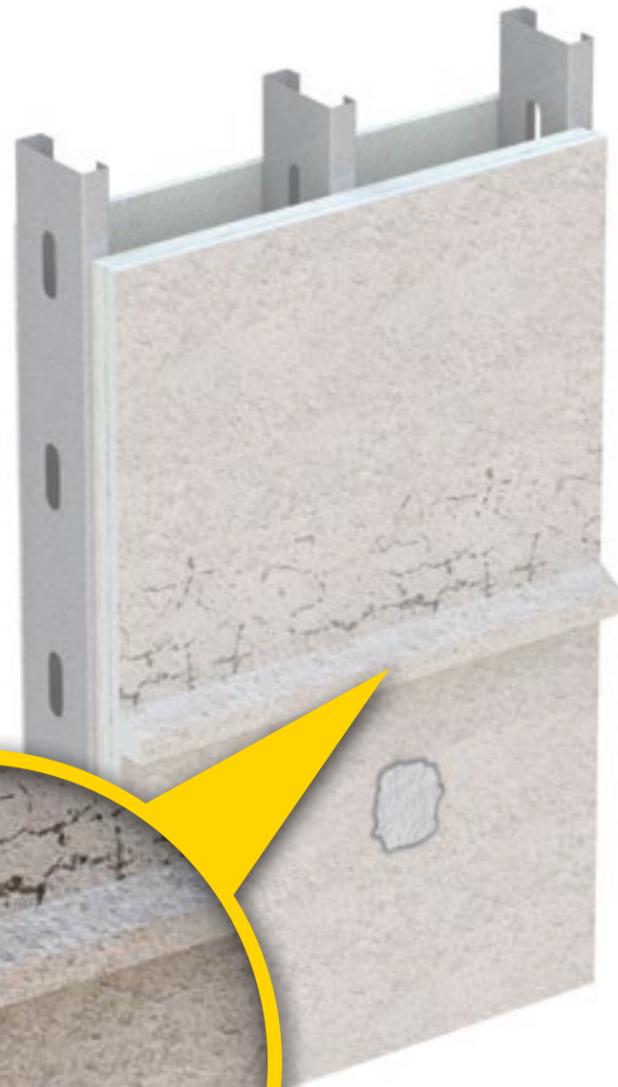
# Refinishing with StoSignature™ Brick

DETERIORATED APPEARANCE OF STUCCO WALL SURFACE

Surface deterioration, patches and superficial cracking can give a dull or shabby look to a sound stucco wall. In a commercial property, surface repairs and an updated finish, in combination with regular maintenance, will improve the curb appeal of the building.

A Level 2 restoration is indicated when the water-shedding surface is basically sound. Surface cracking and minor repairs have not affected the performance of the cladding and the stucco wainscot is undamaged.

Recoating and adding a new finish will extend the life cycle of the cladding. A StoSignature texture applied below the feature band and a new color above will deliver a cost-effective way of achieving a contemporary look.

- 1 **Repair cracks and damage** as per Sto specifications and details. Clean the surface and remove loose or damaged finish.
- 2 **In the area above the wainscot**, prime the wall with Sto Primer tinted appropriately for the new finish color.
- 3 **Recoat the selected area** with StoColor® Lotusan or StoColor® Acryl Plus.
- 4 **Protect the exposed surface** of the wainscot with StoColor® Acryl Plus.
- 5 **Apply Sto basecoat and mesh** to the prepared surface below the wainscot. Allow to cure.
- 6 **Apply StoPrime® UV tinted** to match the selected mortar color.
- 7 **Position the brick** template on the StoPrime® UV.
- 8 **Trowel on the selected** StoSignature Brick texture to match appearance desired.
- 9 **Remove** the brick template.
- 10 **Tint the finish** to match the selected color and appearance using StoTique®.

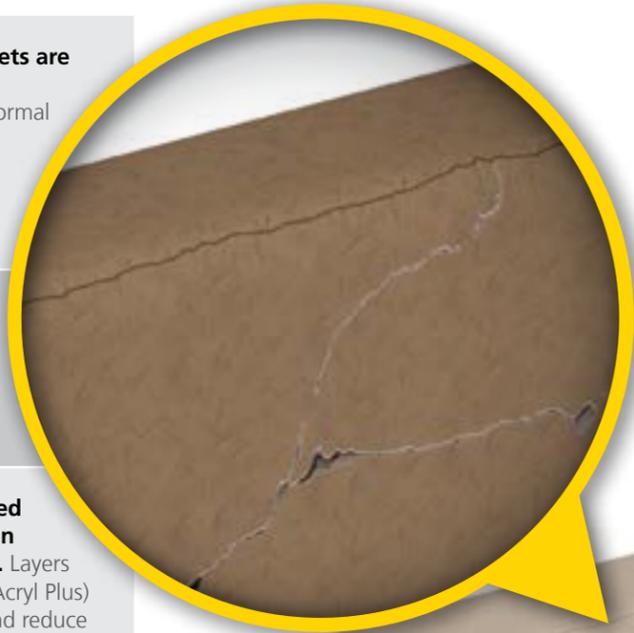
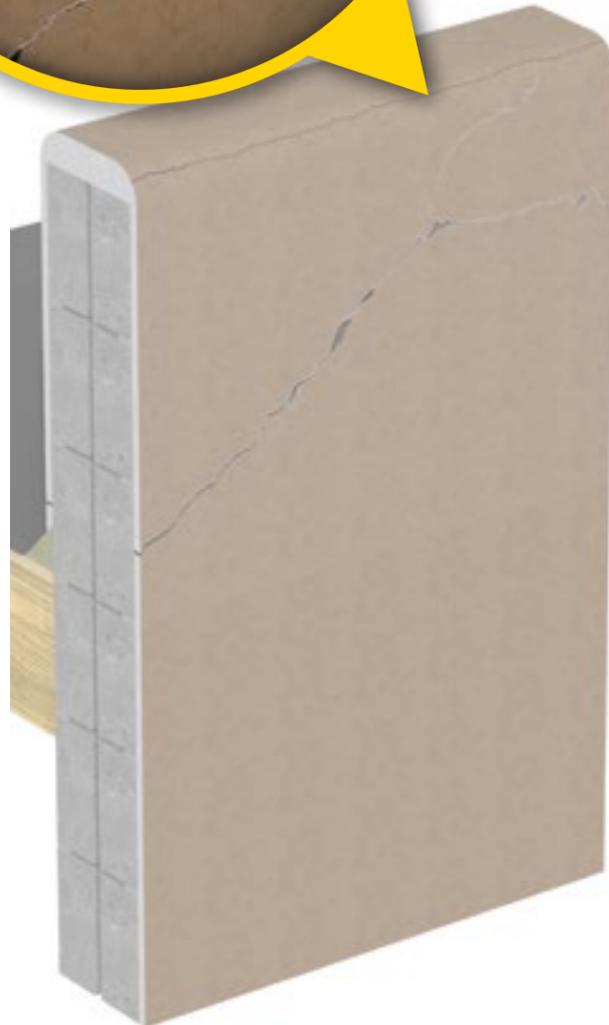
# Stucco Parapet Cap

CRACKED AND DETERIORATED CAP OVER MASONRY WALL

**In hot, dry climates, rounded 'adobe style' parapets are popular but require additional maintenance.** The exposed horizontal surfaces withstand greater than normal solar radiation and heat build-up, conditions that are hard on acrylic coatings. Cracks can result from differential movement between the masonry and the stucco 'cap' rounding the top of the wall.

Deterioration of the coating, dirt accumulation and cracking are generally cosmetic conditions that require standard maintenance.

**The curvature of the parapet cap is easily modified with additional stucco so water and dirt will drain towards the roof and away from the visible wall.** Layers of water-resistant coatings (e.g., Sto Flexyl, StoColor Acryl Plus) will minimize water penetration, improve durability and reduce maintenance.

- 1 **Remove all loose material and finish** from the top of the parapet and clean the wall.
- 2 **Repair** cracks.
- 3 **Direct drainage toward the roof** by modifying the slope of the cap, using additional stucco.
- 4 **Apply Sto basecoat and mesh** to the prepared surface and over the modified parapet. Allow to cure.
- 5 **Install Sto waterproofing membrane and mesh** over the parapet cap and down 6" (150 mm) on each face of the wall, feathering out the edges. Allow to cure.
- 6 **Apply tinted StoPrime® primer** appropriate for the finish selected.
- 7 **Refinish the wall** with the specified Sto materials.
- 8 **For increased durability**, apply two coats of appropriate StoColor® coating to the exposed top surface of the parapet.

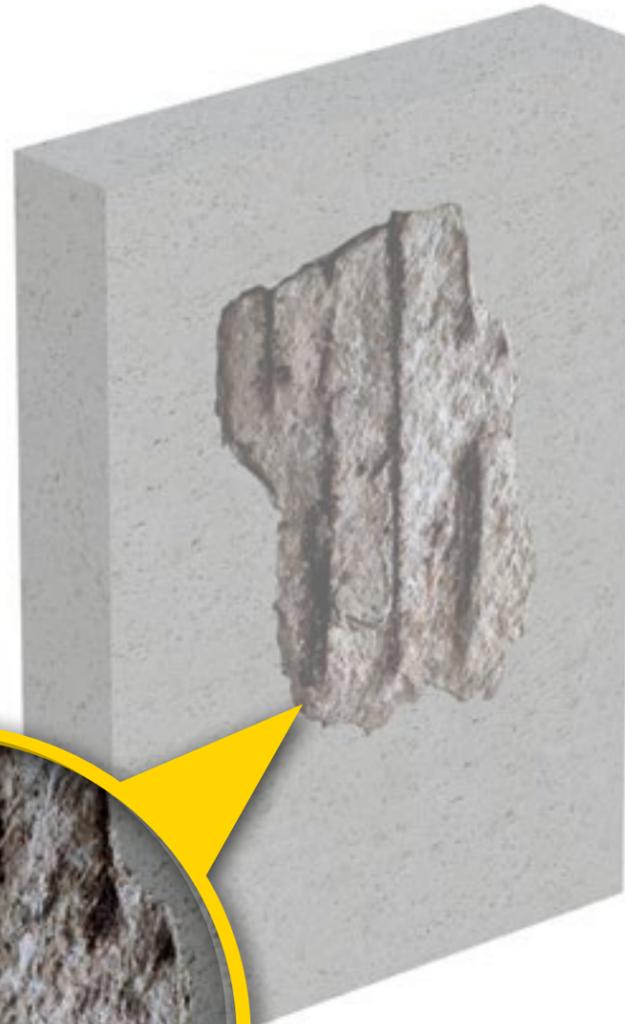
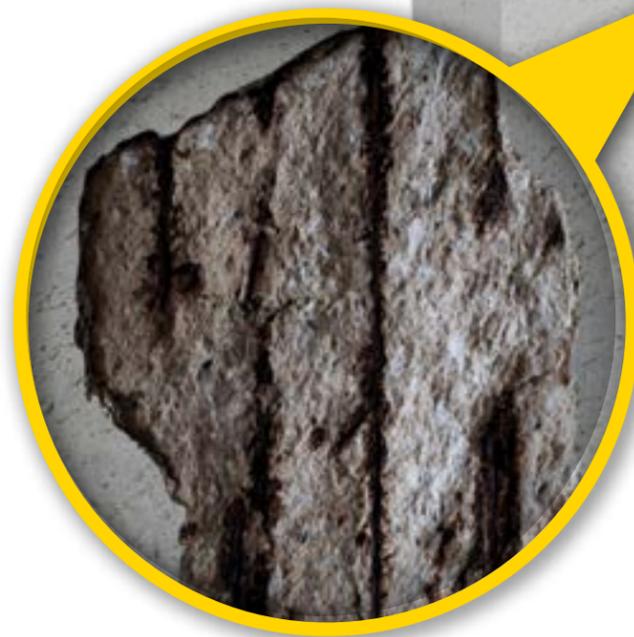
# Concrete Repair - Hand Application

DETERIORATED CONCRETE/MASONRY

Damage to concrete and masonry walls are typically caused by corrosion of embedded metals, disintegration from freezing and thawing cycles, or deterioration from chemical attack.

A Level 2 restoration using a non-sag, structural repair mortar and choice of finish or coating system can be used to make the surface aesthetically pleasing and structurally sound.

- 1 Remove** deteriorated or contaminated concrete.
- 2 Remove or replace** deteriorated or damaged reinforcement.
- 3 Cut the perimeter of the repair area** to the desired, optimal geometry at a 90° angle using a concrete/masonry cutting tool. **Caution:** Repair areas with complicated shapes with reentrant corners are likely to crack. Ideally, all repair areas should be rectangular in shape.

- 4 Prepare the surface of the repair area** to the appropriate CSP (Concrete Surface Profile) for the repair material selected. Refer to ICRI Guideline No. 310.2R "Selecting and Specifying Concrete Surface Preparation..." for information on Concrete Surface Profiles and equipment used to achieve them.

- 5 Apply bond coat** using a scrub coat of the selected repair material or appropriate Sto bonding agent.
- 6 Apply repair material** using a trowel making sure to fully encapsulate reinforcement if applicable. If a second lift is required, score the first lift before it is set using the trowel to create a profile similar to the prepared substrate. Apply second lift after the first lift has reached final set using a scrub coat of repair material, not bonding agent. Allow repair material to properly cure.

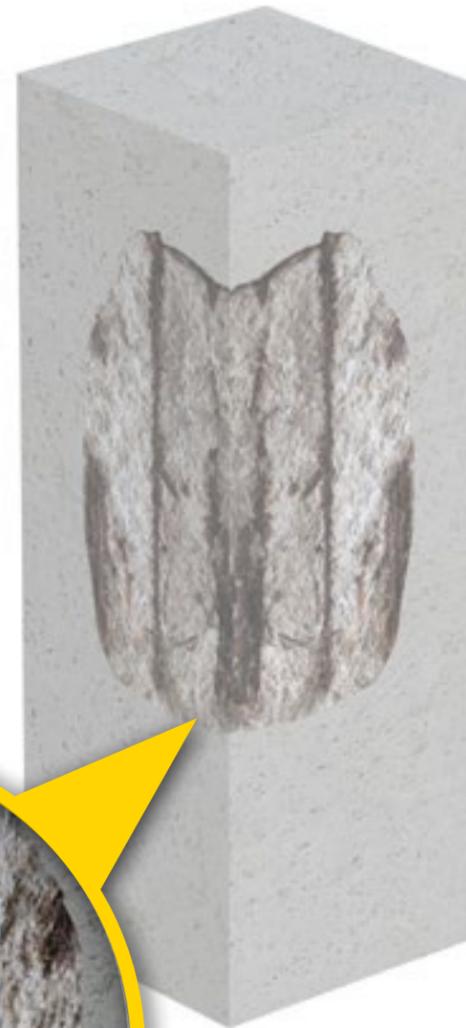
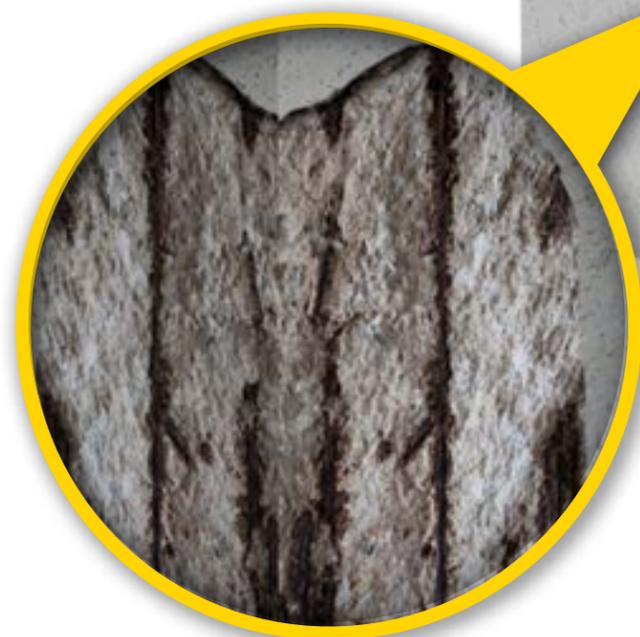
# Concrete Repair - Form and Pour Application

DETERIORATED CONCRETE/MASONRY

Damage to concrete and masonry walls are typically caused by corrosion of embedded metals, disintegration from freezing and thawing cycles, or deterioration from chemical attack.

A Level 2 restoration using a pourable, structural repair mortar and choice of finish or coating system may be used to make the surface aesthetically pleasing and structurally sound.

- 1 Remove** deteriorated or contaminated concrete.
- 2 Remove or replace** deteriorated or damaged reinforcement.
- 3 Cut the perimeter of the repair area** to the desired, optimal geometry at a 90° angle using a concrete/masonry cutting tool. **Caution:** Repair areas with complicated shapes with reentrant corners are likely to crack. Ideally, all repair areas should be rectangular in shape.

- 4 Prepare the surface of the repair area** to the appropriate CSP (Concrete Surface Profile) for the repair material selected. Refer to ICRI Guideline No. 310.2R "Selecting and Specifying Concrete Surface Preparation..." for information on Concrete Surface Profiles and equipment used to achieve them.

- 5 Apply bond coat** using an appropriate Sto bonding agent. **Note:** A scrub coat of the repair material itself will likely dry out during formwork installation causing an inadequate bond. Therefore, a bonding agent with a longer open time is required for form-and-pour and form-and-pump applications.

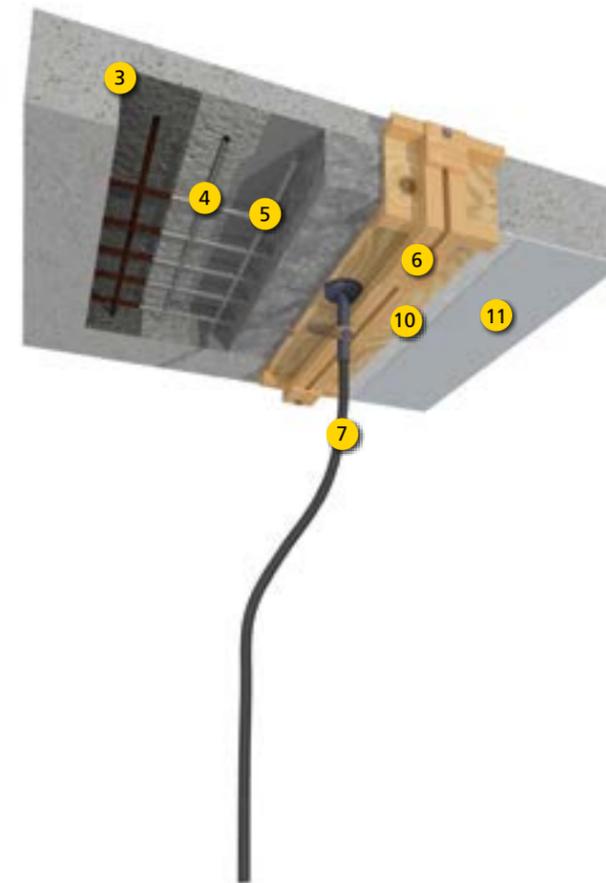
# Concrete Repair - Form and Pump Application

- 1 Remove** deteriorated or contaminated concrete.
- 2 Remove or replace** deteriorated or damaged reinforcement.
- 3 Cut the perimeter of the repair area** to the desired, optimal geometry at a 90° angle using a concrete/masonry cutting tool. **Caution:** Repair areas with complicated shapes with reentrant corners are likely to crack. Ideally, all repair areas should be rectangular in shape.

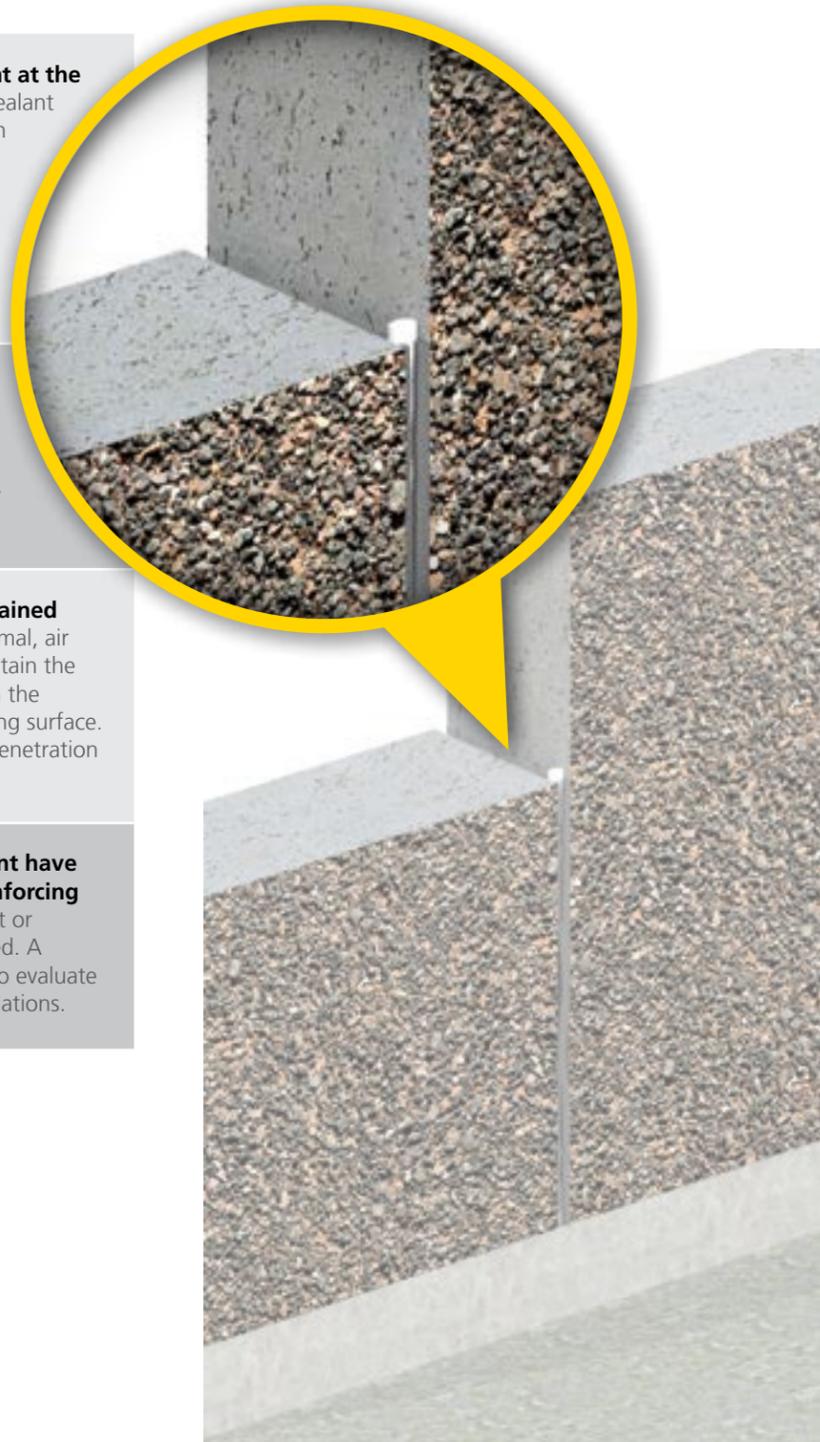
# Replacement of Sealant Joints

**The joints should be replaced with two-stage, drained rainscreen seals.** This will entail installation of a thermal, air and water barrier inbound of the wall surface to maintain the interior environment. A new exterior seal aligned with the restored exterior finish will maintain the water-shedding surface. A cavity between the two seals will allow any water penetration to drain to the exterior.

**If water penetration and condensation at the joint have resulted in deterioration of the concrete, the reinforcing steel may be compromised.** If there are signs of rust or distress in the concrete, further repairs may be required. A third-party envelope professional should be retained to evaluate conditions and make the necessary repair recommendations.

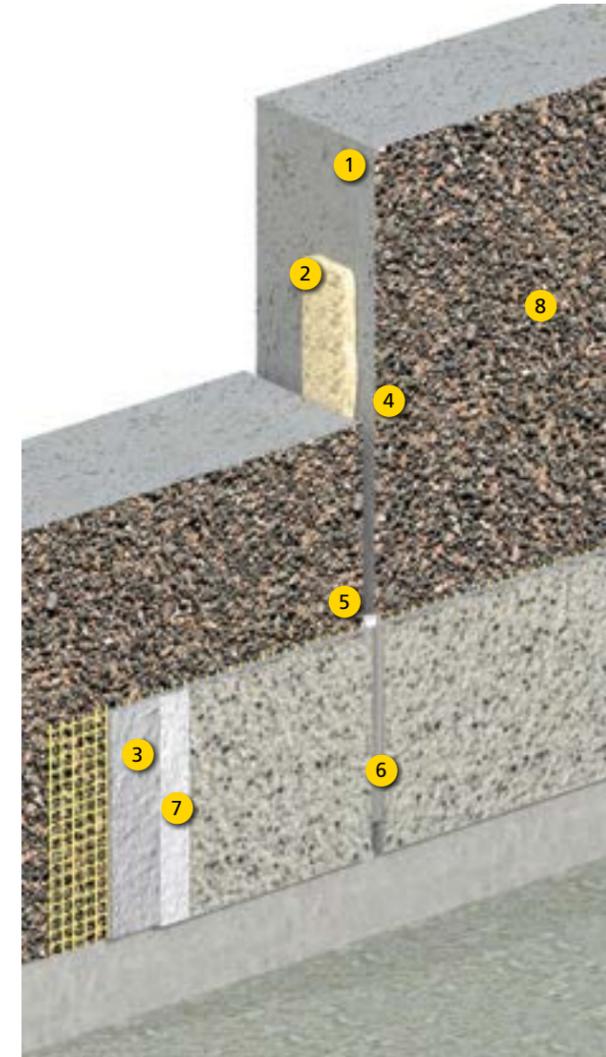
- 1 **Remove all old sealant and backer rod.** Prepare the surface to receive new sealant as per the recommendations of the sealant manufacturer.
- 2 **Install a spray polyurethane foam interior barrier** as per foam manufacturer's instructions.
- 3 **Apply Sto basecoat and mesh** to the prepared surface. Allow to cure.
- 4 **Prime the joint surface** as specified by the sealant manufacturer.
- 5 **Install the backer rod** as recommended, leaving a cavity between the airtight interior barrier and the backer rod.
- 6 **Install the sealant** as per sealant manufacturer's instructions, leaving a gap to allow water to drain to the exterior and the cavity to pressure-moderate.
- 7 **Apply tinted StoPrime® primer** appropriate for the finish selected.
- 8 **Refinish the wall** with the specified Sto materials.

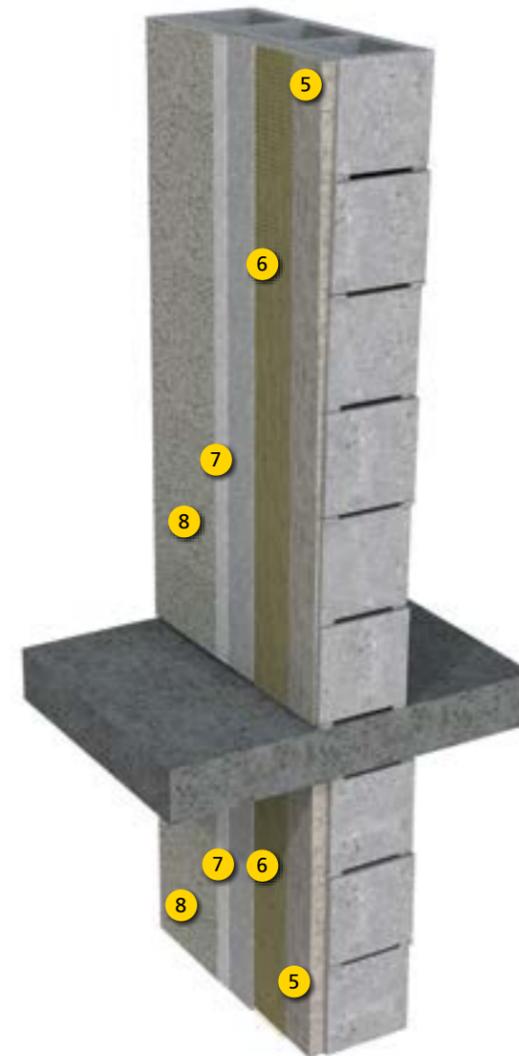
- 1 **Make any necessary repairs** to wall per Sto product instructions.
- 2 **Clean and prepare the surface** to achieve the required CSP (Concrete Surface Profile) as stated in the instructions for Sto Wall Leveler & Patch.

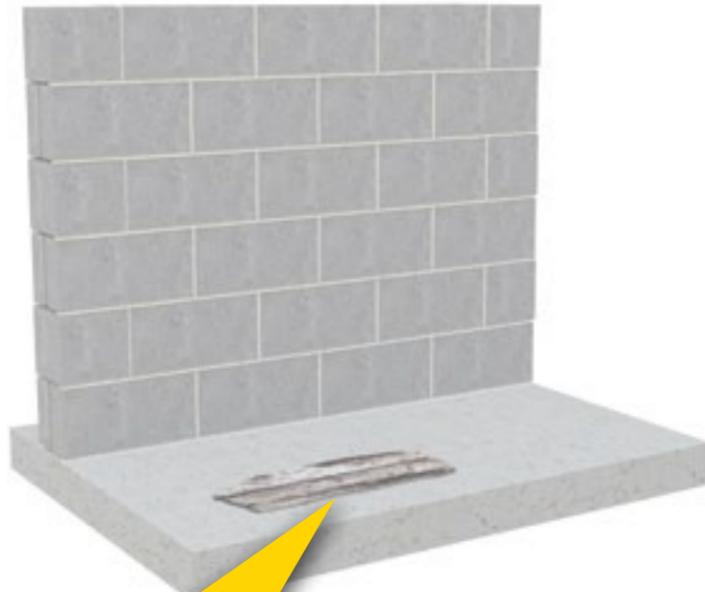
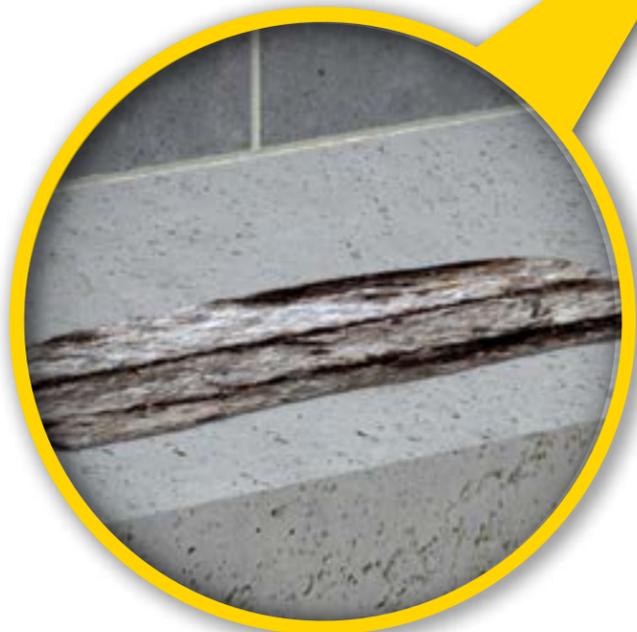
# Repair and Waterproof Balcony/Deck

**Sto provides complete restoration solutions that repair, waterproof, and beautify balconies.** The balcony restoration solution should provide occupants with a safe and aesthetically pleasing outdoor space.

**Damage to reinforcing steel and chloride content of the concrete may be extreme.** If conditions are extreme, a third-party structural and/or corrosion professional should be retained to evaluate conditions and make the necessary repair recommendations.

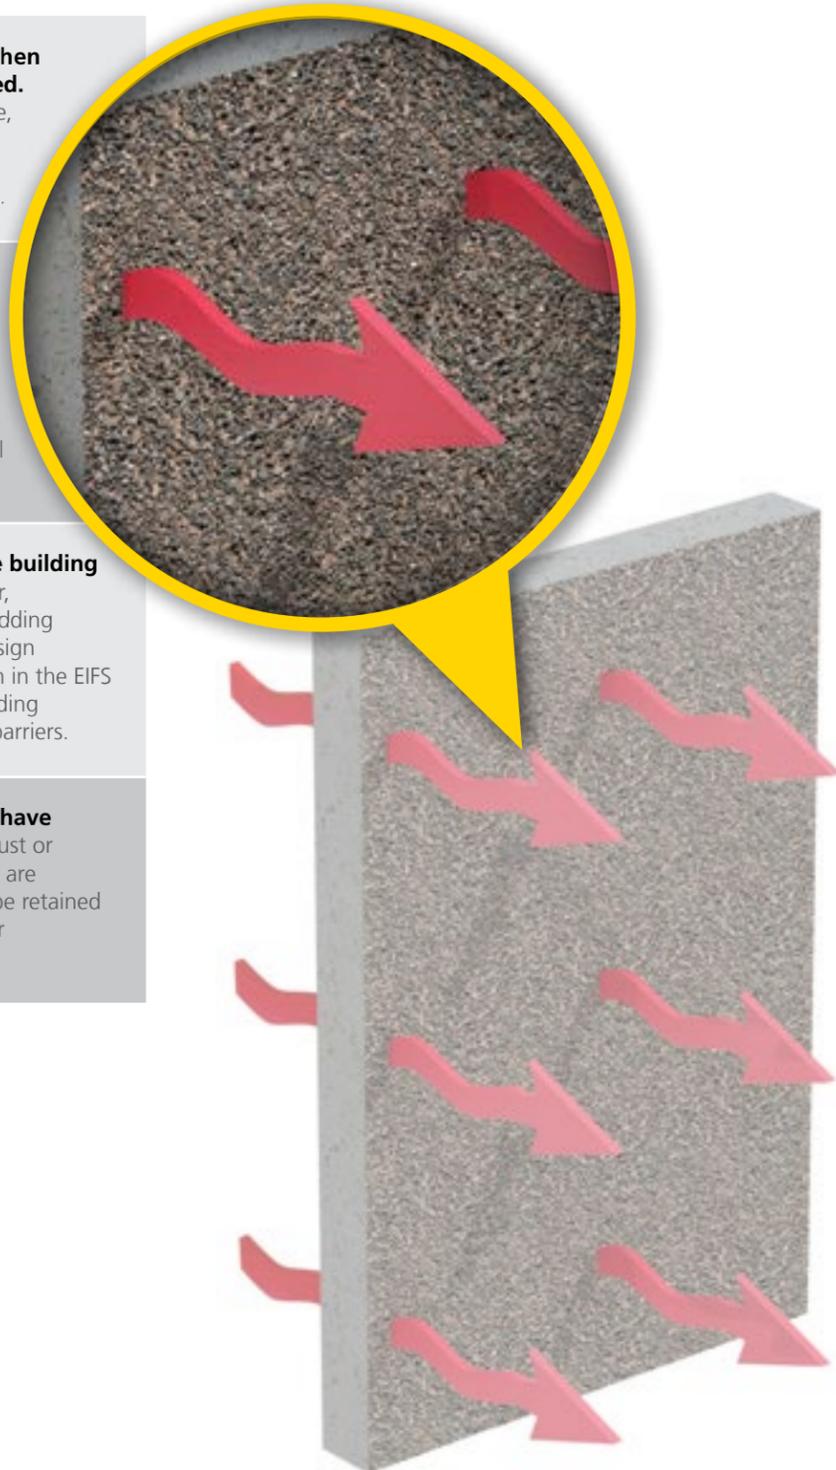
# Thermal Upgrade of Precast

**Damage and deterioration of the concrete may have progressed to the steel reinforcement.**

Signs of rust or spalling are indications of deteriorated rebar. If these are present, A third-party envelope professional should be retained to evaluate conditions and make the necessary repair recommendations.

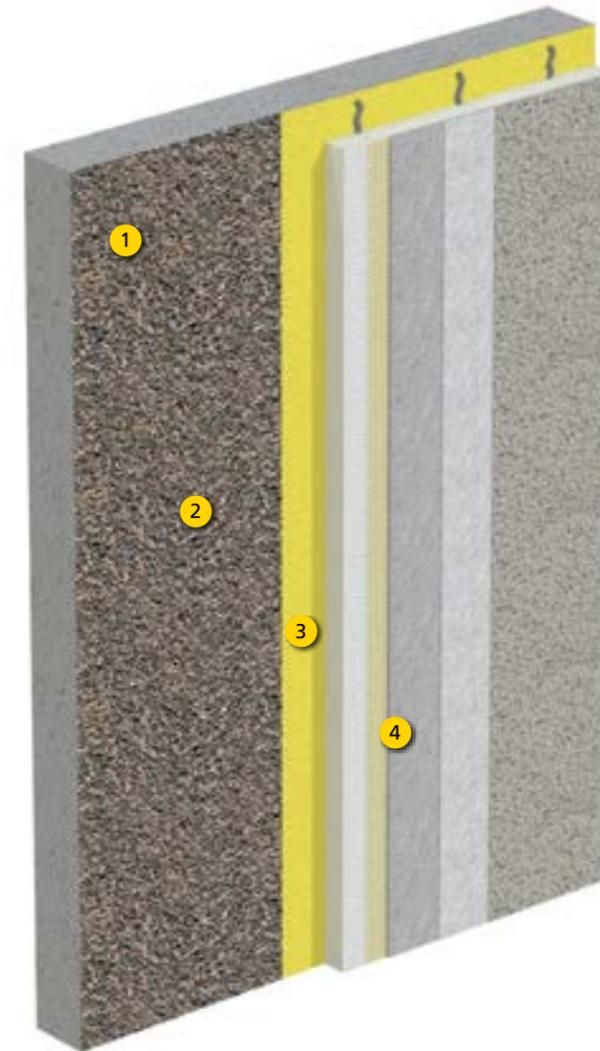
**1 Pressure wash** the wall to remove dirt and loose finish.
