Flashing

The Plain Solution to Leaky Walls

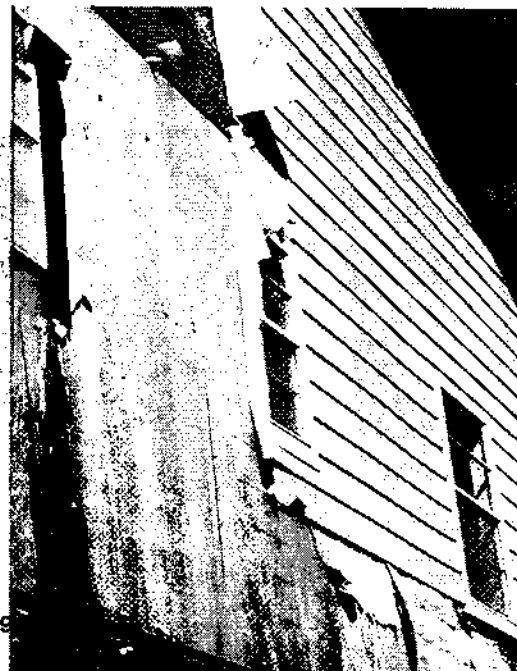
Figure 3 — Unfortunately, sill flashing is often omitted or incomplete beneath windows. The omission of flashing that would conduct window leakage to the exterior has caused wood rot beneath this window. Note that the presence of building paper and a housewrap material behind the siding failed to prevent water damage. The code must have clear, unambiguous requirements to prevent this problem. The window industry must play a role in developing such requirements.

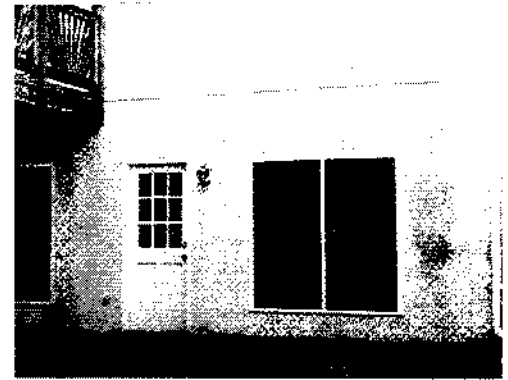
Figures 4 and 5 — The ramifications of flashing omission or improper installation at window heads can be serious, as demonstrated by these photographs of areas where flashing was omitted above the windows and wood trim. The wood window head and trim above the window show signs of rot, while the conventional stucco wall covering has cracked and spalled.
