Tech Hotline

No. 0611-BSc
Rev: July, 2011

Self-sealing and Self-healing of Air Barriers and Water-Resistive Barriers

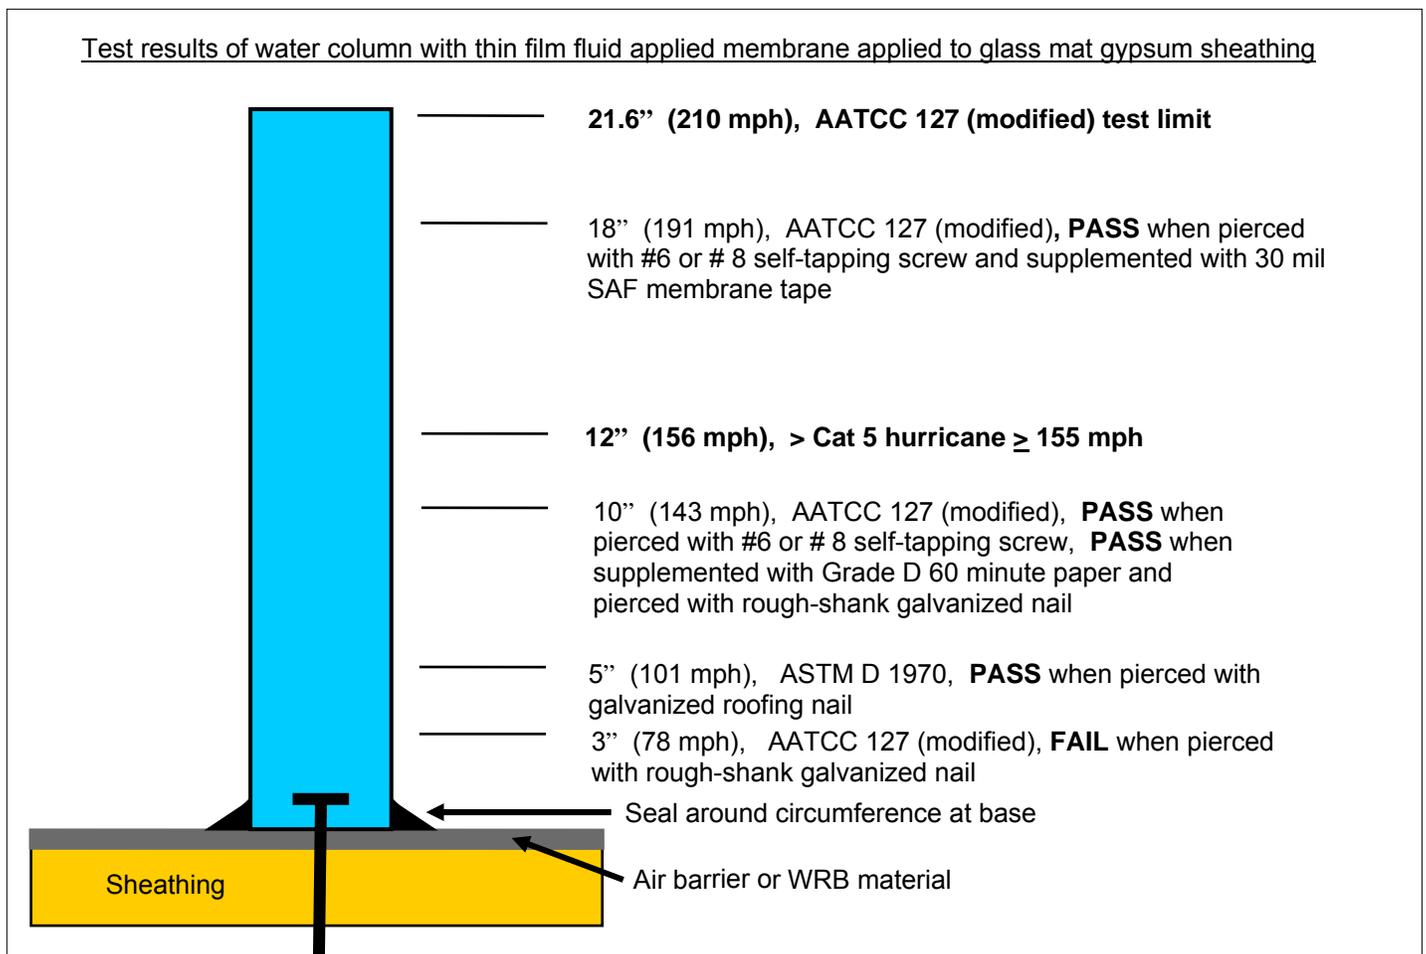
Figure 1. ASTM D 1970 [2] and AATCC 127 [4] modified test are both water column tests. The D 1970 [2] standard requires testing with a 5 inch head of water, while the AATCC 127 modified test [4] method requires testing with a 21.6 inch head of water, though without a fastener penetration. Modifications of these tests with graduated levels of water can be used to evaluate water penetration through air barriers or WRBs with various types of fasteners and sheathing types. Screw fasteners perform best, while a rough-shank galvanized nail consistently has the worst results, regardless of membrane type. Supplementing the fluid applied membrane with a 60 minute building paper or SAM tape also improves performance.

Another water column test that has been used to evaluate *self-sealing* is American Association of Textile Chemists and Colorists Hydrostatic Pressure Test AATCC 127 [4] modified method. In this test a 21.6 inch head of water (correlates to 210 mph wind speed) is placed over a fastener penetration driven through sheathing with the fastener head not quite flush with the surface, and the sample is examined for evidence of water penetration at the underside of the fastener penetration. This modified test method has been incorporated into International Code Council Evaluation Service Acceptance Criteria 212 (ICC ES AC 212) [5] and E 2570 [6], which require a water-resistive coating to prevent water penetration to the underside for 5 hours. The acceptance criteria does not require fastener penetrations to be evaluated, but the test method can be easily modified to include fastener penetrations as depicted in Figure 1.

A summary of results for each of these tests is shown in Figure 1 (water column tests) and Figure 2 (E 331 test) [9] using several air barrier and/or WRB materials commonly used in construction. Based on these results many materials used in wall assemblies as air barriers and/or WRBs would seem to meet the definition of self-sealing at relatively high levels of exposure. For example, the fluid applied membrane, when pierced with a screw fastener, withstands an exposure comparable to a 143 mph wind based on water column testing. When a supplemental membrane, 60 minute felt, is applied over the fluid applied material, the same pressure level is withstood when pierced with a rough-shank galvanized nail, the worst case fastener penetration. All membranes in the water spray testing demonstrated performance up to the 49 mph level and only 1 or 2 fasteners leaked at the higher levels.

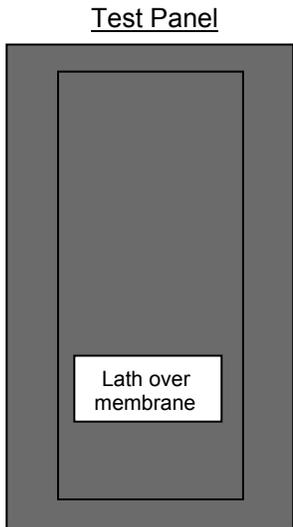
Summary test results of water spray with incremental pressure increase applied to panel with metal lath over Air Barriers and/or WRBs

Pressure						
mph	14.9	24.7	49.3	66.4	76.5	117	150
psf	0.57	1.57	6.24	12.00	15.00	35.00	57.6
in/H ₂ O	0.11	0.3	1.2	2.3	2.9	6.7	11.1
WRB							
#15 Felt	√	√	√	√	1	2	2
60 min. Felt	√	√	√	1	1	2	NT
Thin Film FI Applied	√	√	√	√	1	2	2
40 mil SAM	√	√	√	√	1	1	2

Notes:
 √ = no leaks detected at back plane (back of studs) of specimen
 1 = leak at lath fastener
 2 = leak at 2nd lath fastener
 NT = not tested
 All tests pressure levels done in succession. 150 mph pressure level tested for less than 5 minutes, all other levels tested for 15 minutes.
 Membrane air barrier or WRB over sheathing surface. Metal lath attached at 7 inches oc (26 penetrations) with #8 pan head screws into 16 inch oc metal studs. Panel edges sealed.

Figure 2. ASTM E 331 [9] test with increasing severity of exposure (test pressure) gives the opportunity to evaluate multiple fastener penetrations and a better replication of field installation. The test in this case was done without the benefit of a cladding (stucco, brick, adhered masonry veneer [manufactured stone], siding) over the assembly.

In order to gain more insight into how different materials perform with respect to water leakage and *post-applied* fasteners, E 331 [9], a test intended to determine water leakage through windows and curtain walls, was used to evaluate water leakage through *post-applied* fastener penetrations (Figure 2) and several membrane materials. To some extent the test provides a more realistic evaluation than water column testing, since the panel size encompasses multiple fastener penetrations, which is more likely to capture installation variability that can occur in the real world. The test applies a uniform static pressure to a panel of 2.86 psf (correlates to 33 mph wind speed) for a period of 15 minutes with a standard flow rate of water from spray nozzles directed at the panel. Both pressure and period of exposure can be increased, depending on specification requirements, or the desired exposure severity that one seeks in the test. In this particular case test pressures started at relatively low levels, and were ramped up to increasingly more severe levels that exceeded hurricane force winds.

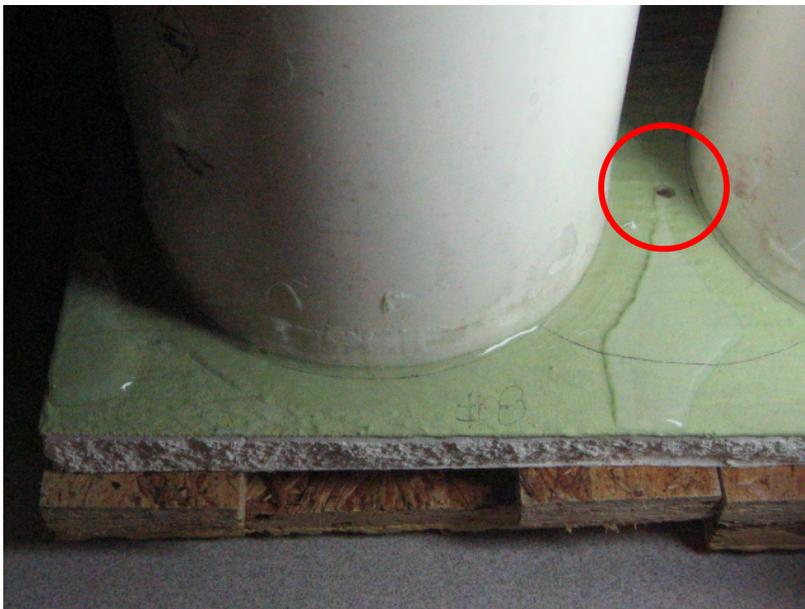
Photo 1. The photo depicts water column testing (the base of two columns are visible) and the presence of water percolating up through the sheathing material during the test (red circle) despite the fact that there was no evidence of water penetration on the back side of the specimens at fastener penetrations. This leads to the conclusion that water by-passed the membrane and traveled within the core of the sheathing.

However, discoveries made during tests and inspection of samples after tests led to some other findings. The absence of water on the back side of an assembly or test specimen does not necessarily mean that water has not penetrated the plane of the membrane. In the case of the AATCC 127 [4] modified test, water can be seen along edges of specimens or percolating up through an adjacent hole in the membrane material (Photo 1), without detecting any water penetration on the back side of the specimen. In the case of the E 331 [10] test, evaluation of specimens after testing showed minor water stains at virtually all fastener penetrations, though only one or at most two leaks were noticed along the back side of the specimens during tests. Thus, some degree of leakage past the plane of the membrane occurs through fastener penetrations during the tests, and leakage may not be immediately evident on the back side of test specimens.
